# University of Missouri For The Curators of the University of Missouri MU Project number CP220041 Advertisement Date: January 18, 2022 Various Locations - Repair Concrete in Steam Manholes

**CP220041 - VARIOUS LOCATIONS  
REPAIR CONCRETE IN STEAM MANHOLES**  
**UNIVERSITY OF MISSOURI  
COLUMBIA, BOONE COUNTY, MISSOURI**

DRAWING INCLUDES:  
 SMH #023  
 PLAN & PHOTOS

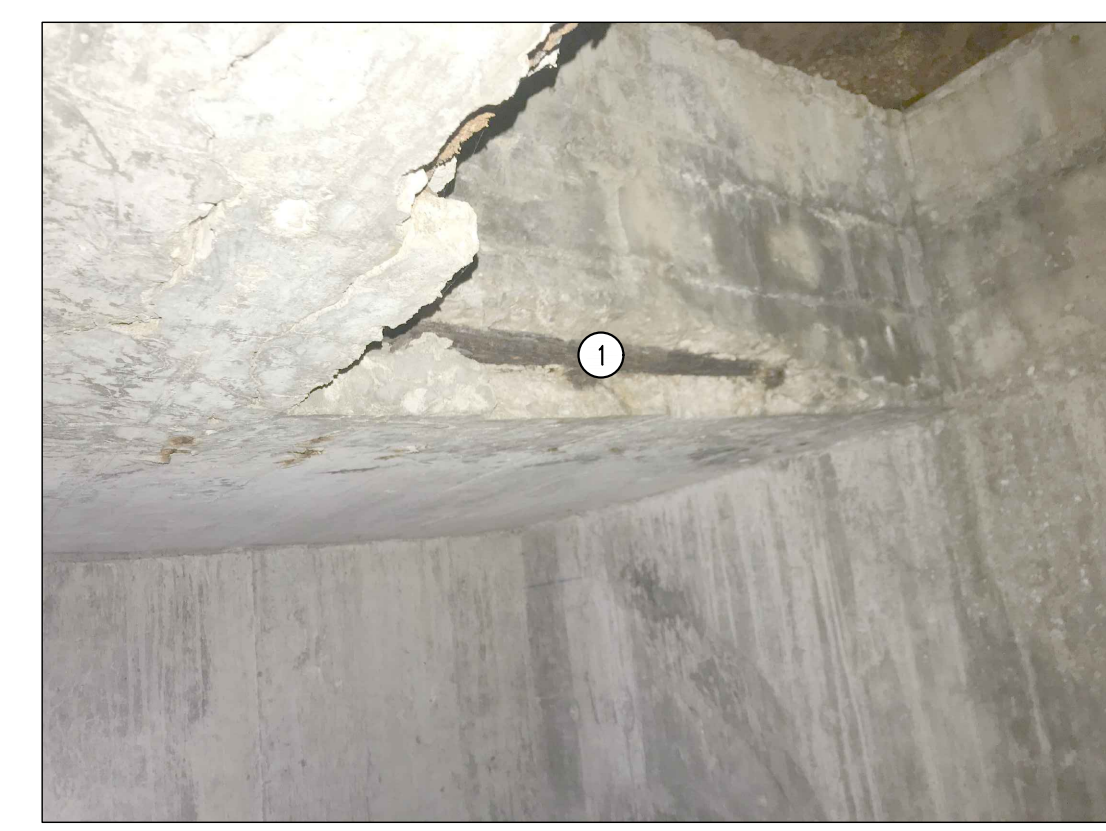
1 EXPOSED REBAR, SEE REPAIR NOTE 2.

- SMH #023 APPROXIMATE REPAIR AREAS
- IN THE LID AROUND THE WEST RISER THERE IS REBAR EXPOSED AND 18 INCH WIDE SPALLING ON BOTH SIDES X 3 INCH DEEP. (REPAIR #3 EXPECTED)
  - IN THE LID AROUND THE EAST RISER AND 12 INCHES INTO THE RISER THERE IS SPALLED CONCRETE 18 INCH WIDE ON BOTH SIDES X 2 INCH DEEP. (REPAIR #2 EXPECTED)
  - JUST UNDER THE WEST MANHOLE LID, THERE IS SPALLED CONCRETE 3 INCHES TALL X 24 INCHES WIDE X 2 INCHES DEEP. (REPAIR #2 EXPECTED)
  - THE EAST CHASE LOWER NORTH CORNER HAS SPALLED 4 INCHES THICK X 18 INCHES LONG X 6 INCHES DEEP. (REPAIR #3 EXPECTED)
  - THERE ARE A TOTAL OF 7 FEET OF CRACKS THAT WILL NEED TO BE EPOXY INJECTED WITH SIKADUR INJECTION GEL OR APPROVED EQUAL AT BOTH CHASE OPENINGS.

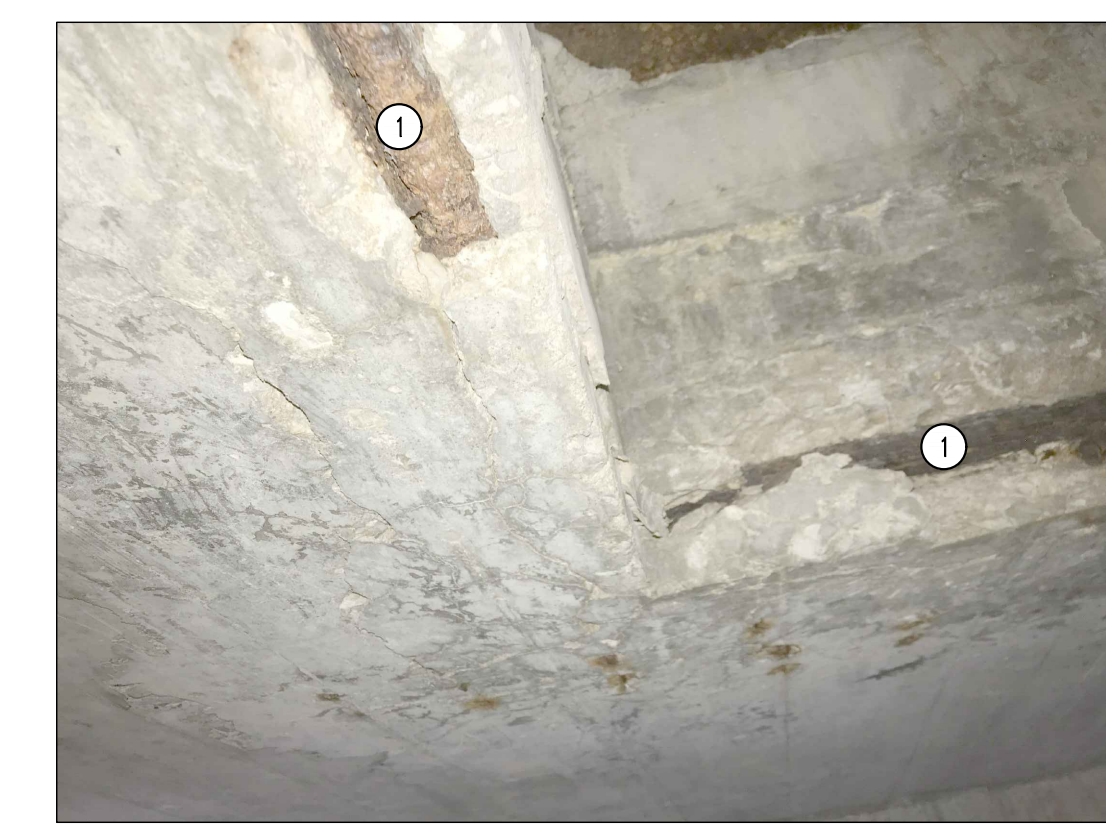
1 EXPOSED REBAR, SEE REPAIR NOTE 2.

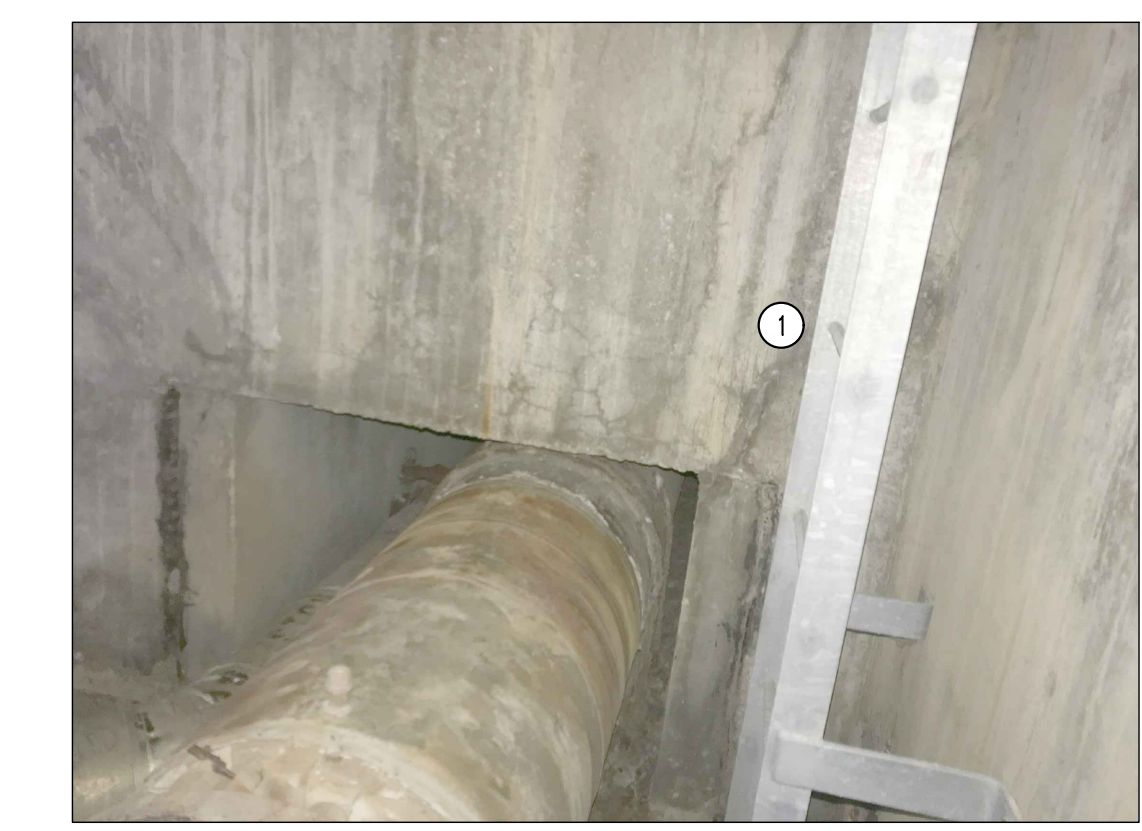
1 CONCRETE CRACK, SEE REPAIR NOTE 5.

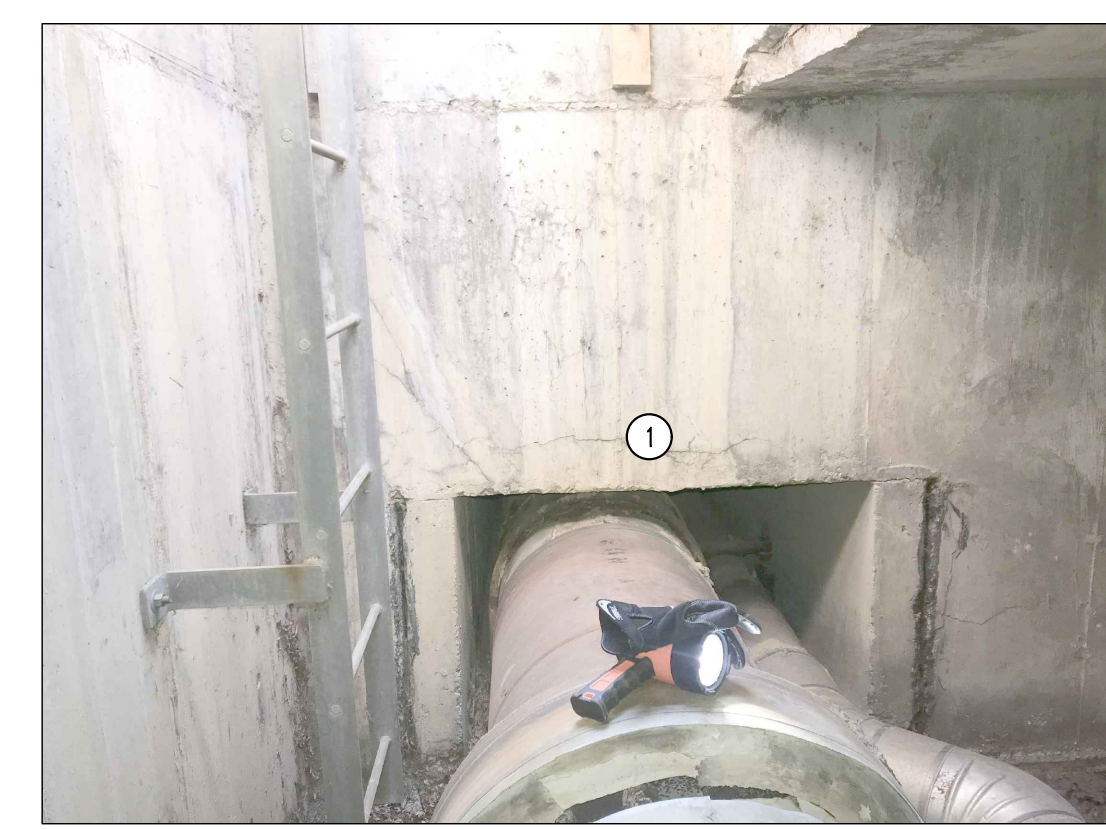
1 SPALLED CONCRETE, SEE REPAIR NOTE 4.

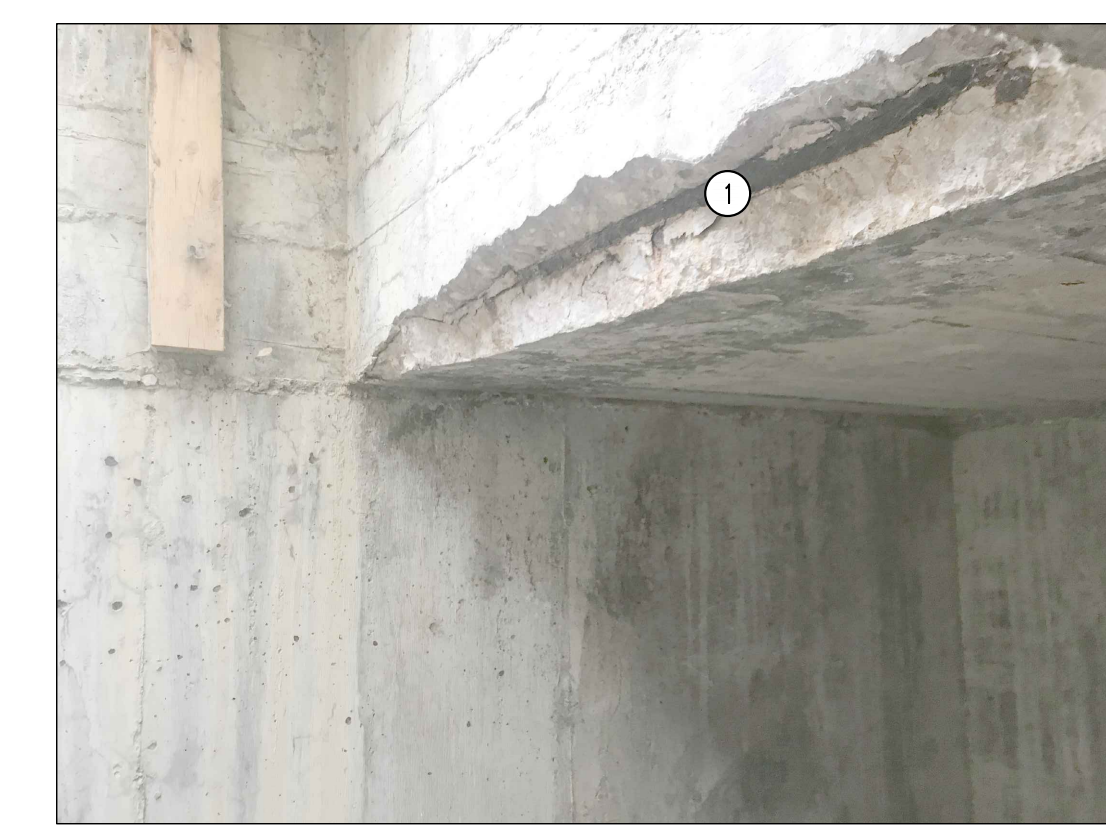
1 EXPOSED REBAR, SEE REPAIR NOTE 2.

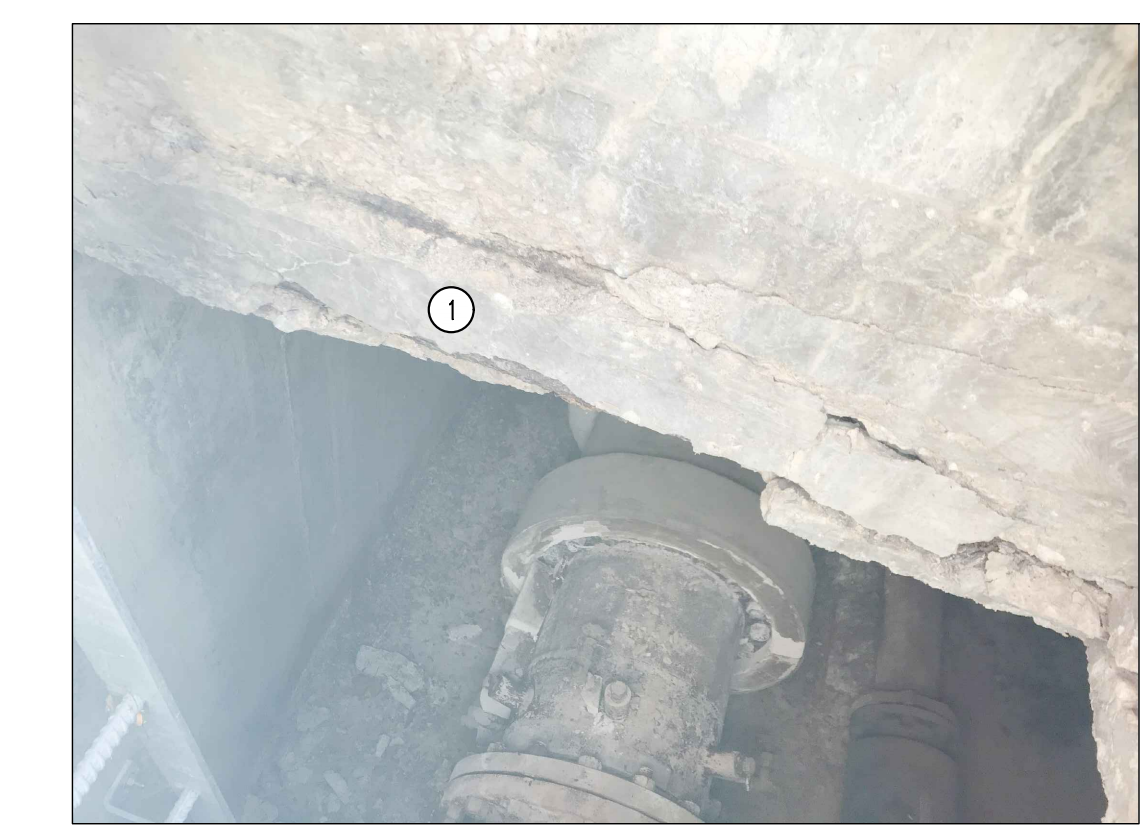
1 SPALLED CONCRETE, SEE REPAIR NOTE 4.

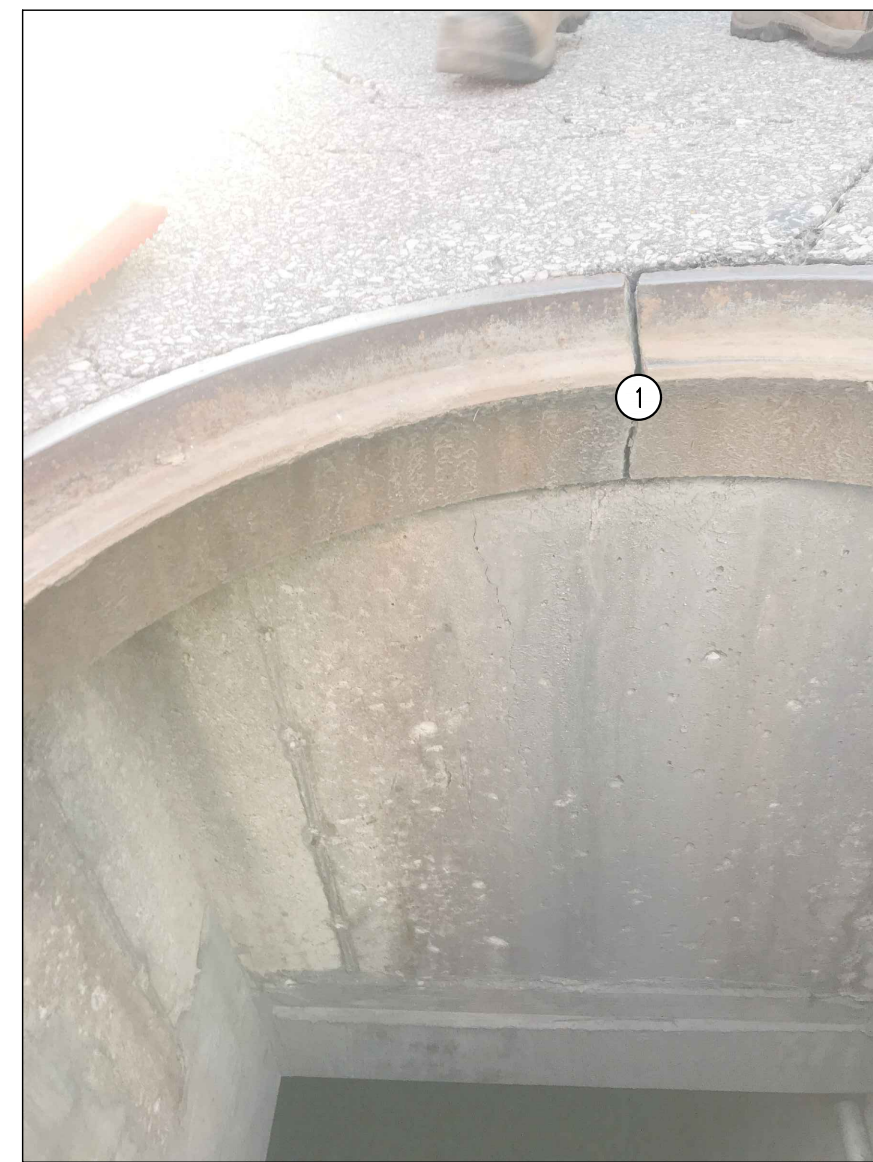
1 CRACKED CAST IRON RING, SEE REPAIR NOTE 1.

- EXISTING 36" CAST IRON RING TO BE REPLACED.

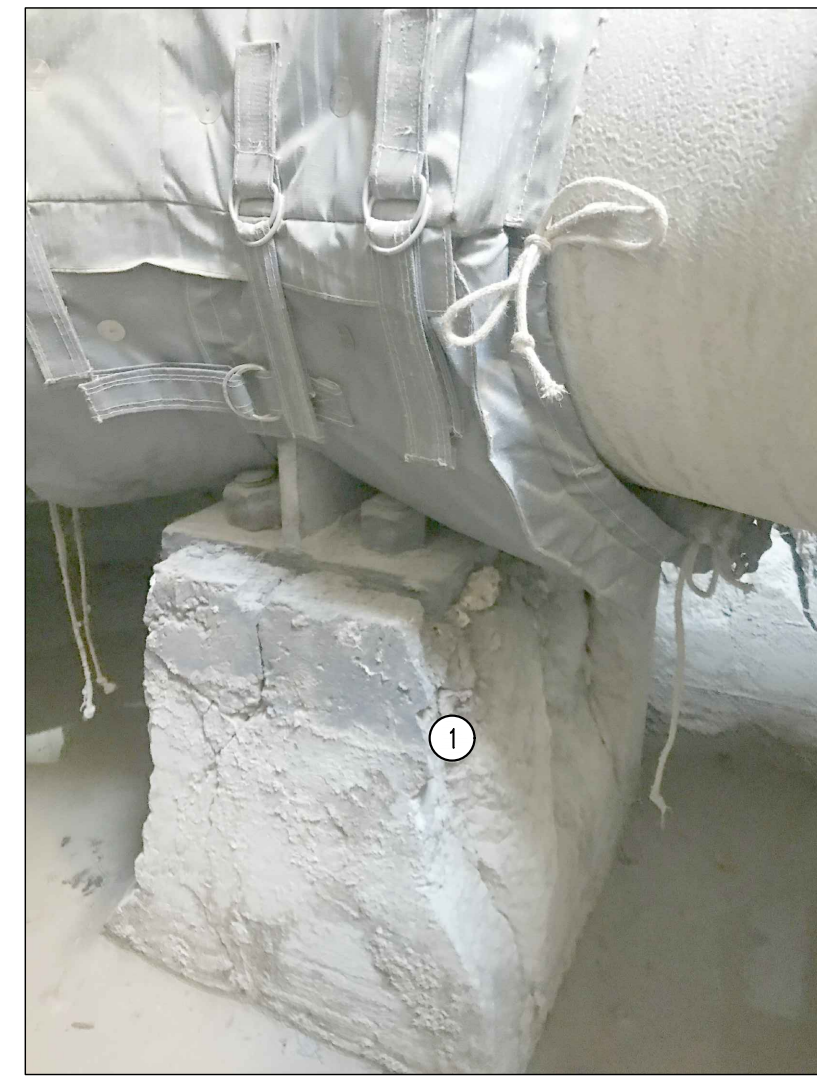
1 SPALLED CONCRETE, SEE REPAIR NOTE 1.

- SMH #324 APPROXIMATE REPAIR AREAS
- THERE IS AN 24 INCH X 20 INCH X 22 INCH TALL ANCHOR w/ 3 INCH DEEP CRACKS ALL AROUND. (REPAIR #3 EXPECTED) CONTRACTOR TO CONTACT EM PRIOR TO REPAIR OF ANCHOR TO COORDINATE UTILITY SHUTDOWN AS NEEDED, STEAM LINES WILL ONLY BE ABLE TO BE SHUT DOWN ONE AT A TIME AND ANCHORS WILL ONLY BE ABLE TO BE REPAIRED ONE AT A TIME.
  - THERE IS AN 40 INCH X 42 INCH X 22 INCH TALL ANCHOR w/ 3 INCH DEEP CRACKS ALL AROUND. (REPAIR #3 EXPECTED) CONTRACTOR TO CONTACT EM PRIOR TO REPAIR OF ANCHOR TO COORDINATE UTILITY SHUTDOWN AS NEEDED.
  - DAMAGED BRICK RISER TO BE REMOVED & REPLACED, REFER TO DETAIL 2/S203.

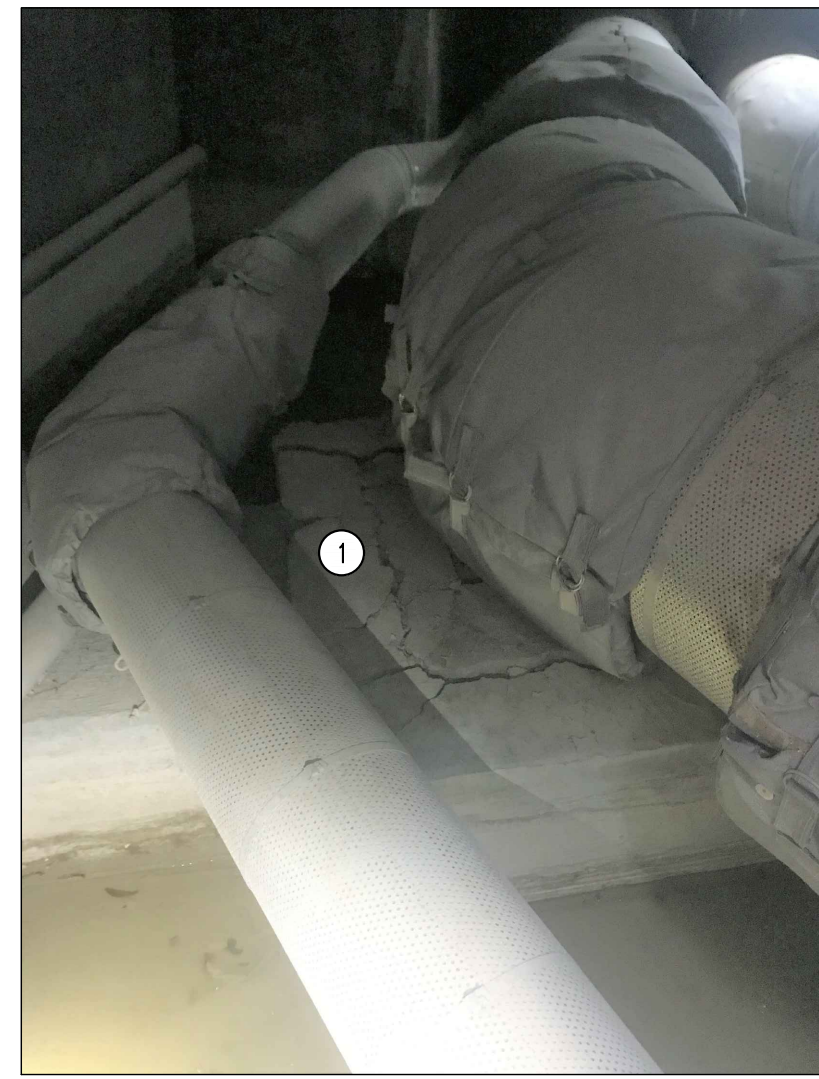
1 SPALLED CONCRETE, SEE REPAIR NOTE 1.

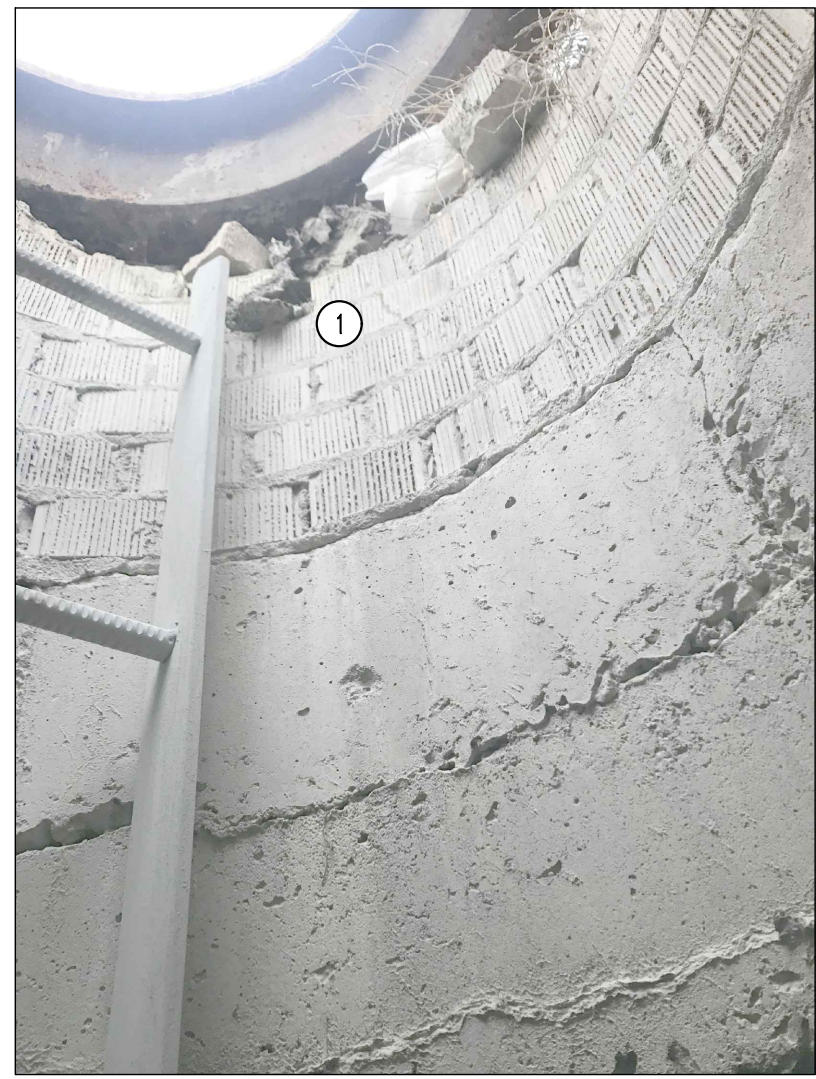
1 DAMAGED BRICK RISER, SEE REPAIR NOTE 3.

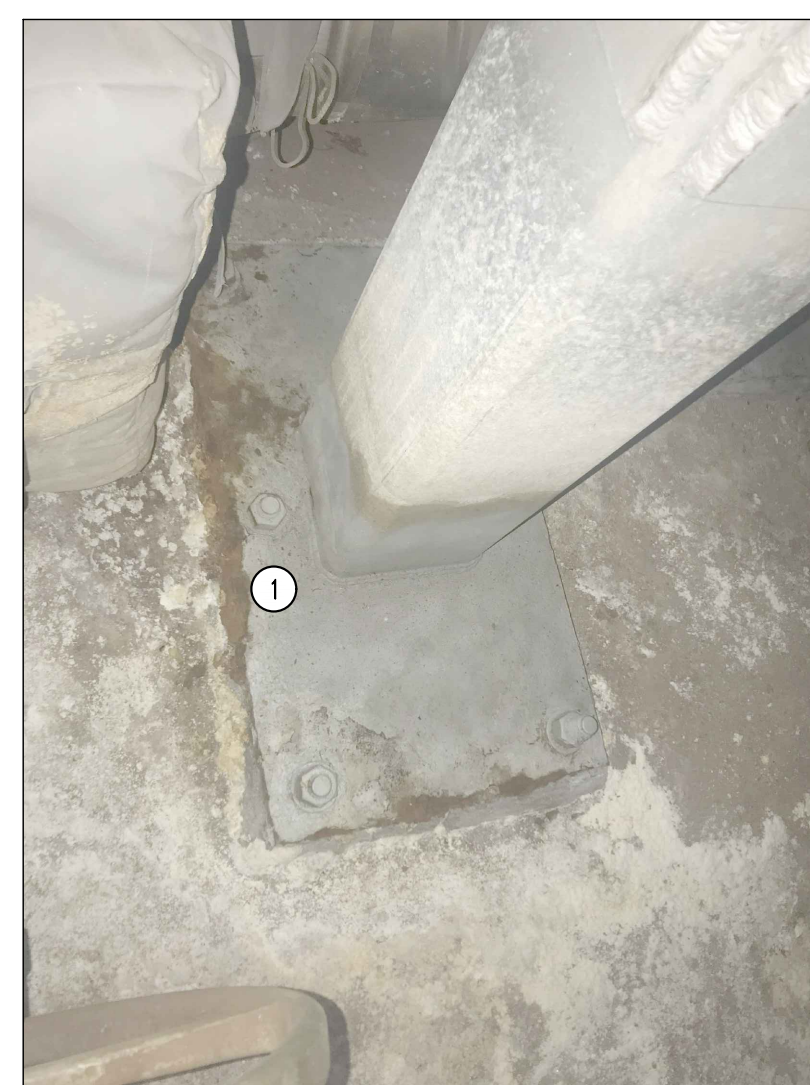
1 DAMAGED BASE PLATE, SEE REPAIR NOTE 2.

- AROUND THE CHASE THERE IS REBAR EXPOSED AND 26"x26" SPALLING X 3 INCH DEEP. (REPAIR #3 EXPECTED)
- (4) EXISTING HSS COLUMNS REQUIRE NEW BASEPLATES. SEE DETAIL 2/S204. PRIOR TO REPAIR, STEAM SYSTEM WILL NEED TO BE SHUT DOWN TO WORK ON THIS ELEMENT, STEAM LINES WILL ONLY BE ABLE TO BE SHUT DOWN ONE AT A TIME AND ANCHORS WILL ONLY BE ABLE TO BE REPLACED ONE AT A TIME. CONTRACTOR SHALL COORDINATE WITH OWNER ONE WEEK IN ADVANCE FOR SYSTEM SHUT DOWN. ADDITIONALLY, NEW EXPANSION ANCHORS INTO LID ARE REQUIRED WHERE ONES HAVE NOT BEEN INSTALLED. USE SAME ANCHORS AS IN BASEPLATE DETAIL. CONTRACTOR PROVIDE VERTICAL PIPE SUPPORT PRIOR TO REPAIR. REMOVE TEMPORARY BRACING ONCE NEW BASE PLATES ARE INSTALLED

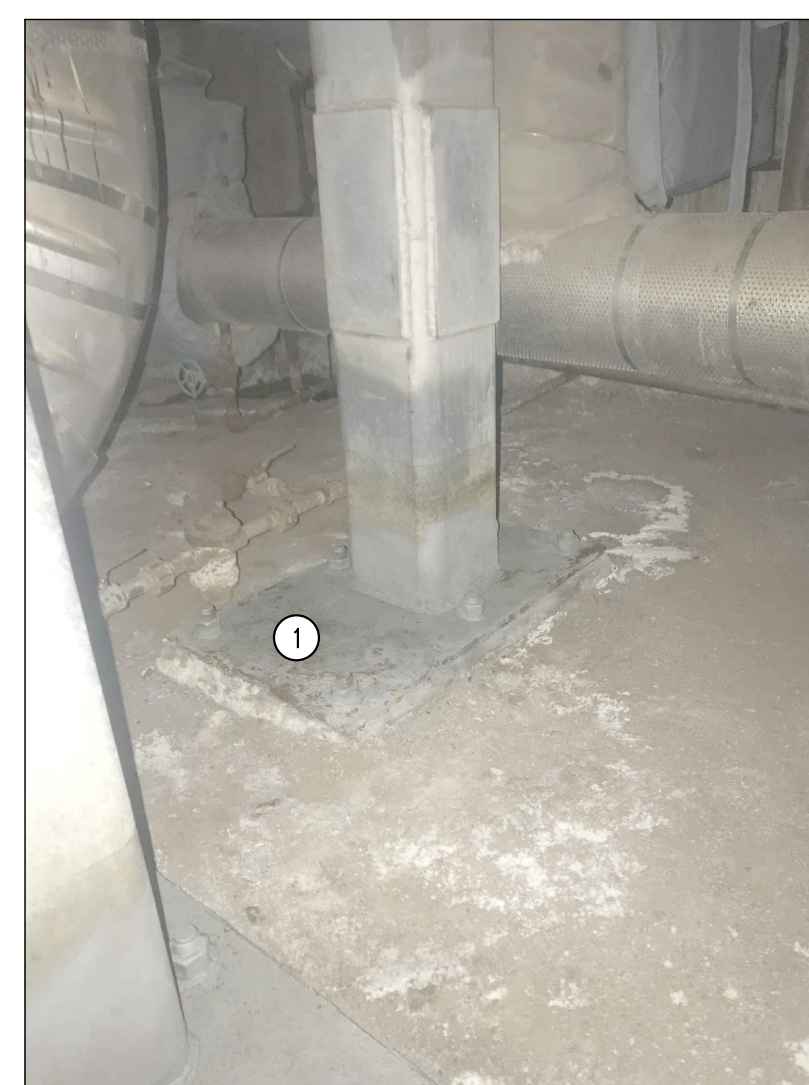
1 DAMAGED BASE PLATE, SEE REPAIR NOTE 2.

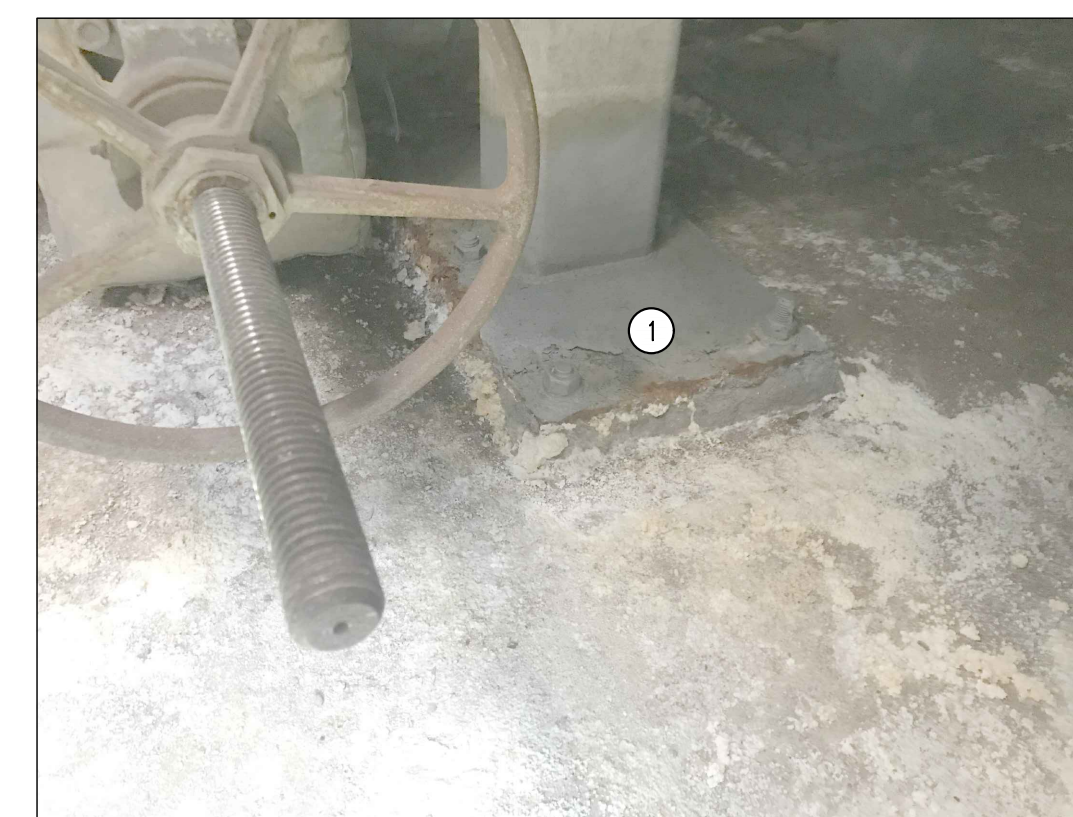
1 DAMAGED BASE PLATE, SEE REPAIR NOTE 2.

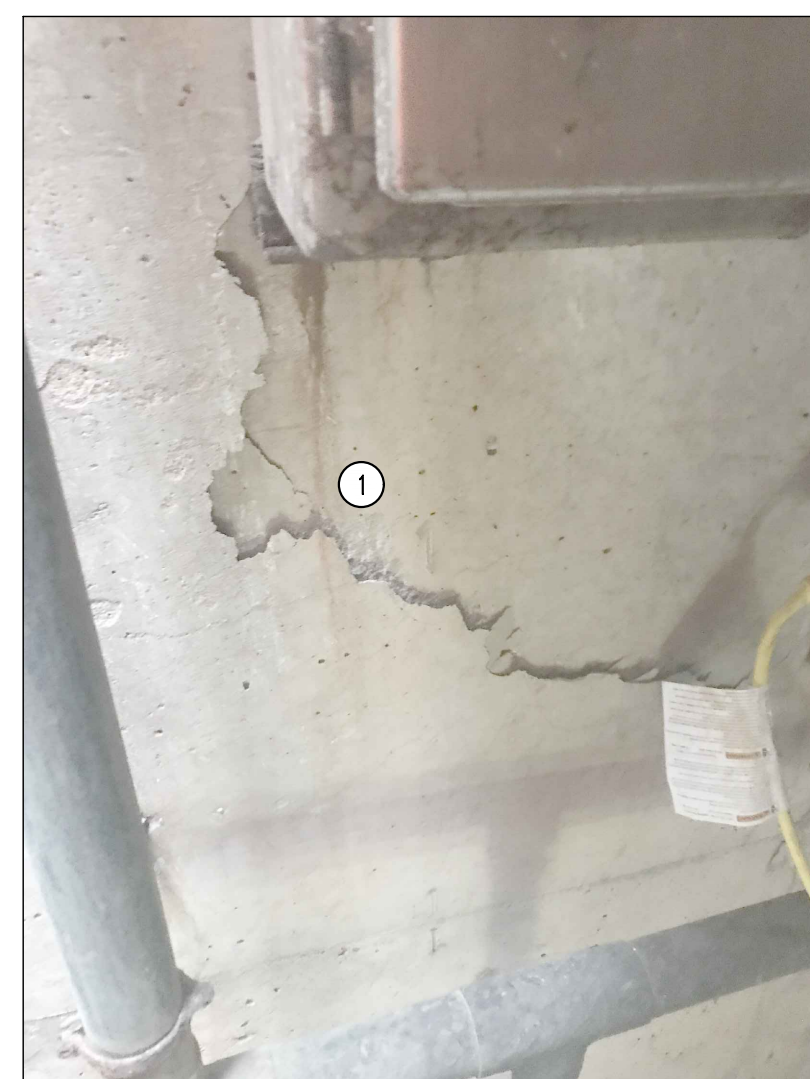
1 SPALLED CONCRETE, SEE REPAIR NOTE 3.

- 36" WIDE SPALLING BEHIND LADDER (REPAIR #1 EXPECTED)
- SPALLING AT CONCRETE PATCHED AREAS NEAR BOTH RISERS (REPAIR #1 EXPECTED)
- THERE ARE A TOTAL OF 4 FEET OF CRACKS THAT WILL NEED TO BE EPOXY INJECTED WITH SIKADUR INJECTION GEL OR APPROVED EQUAL.

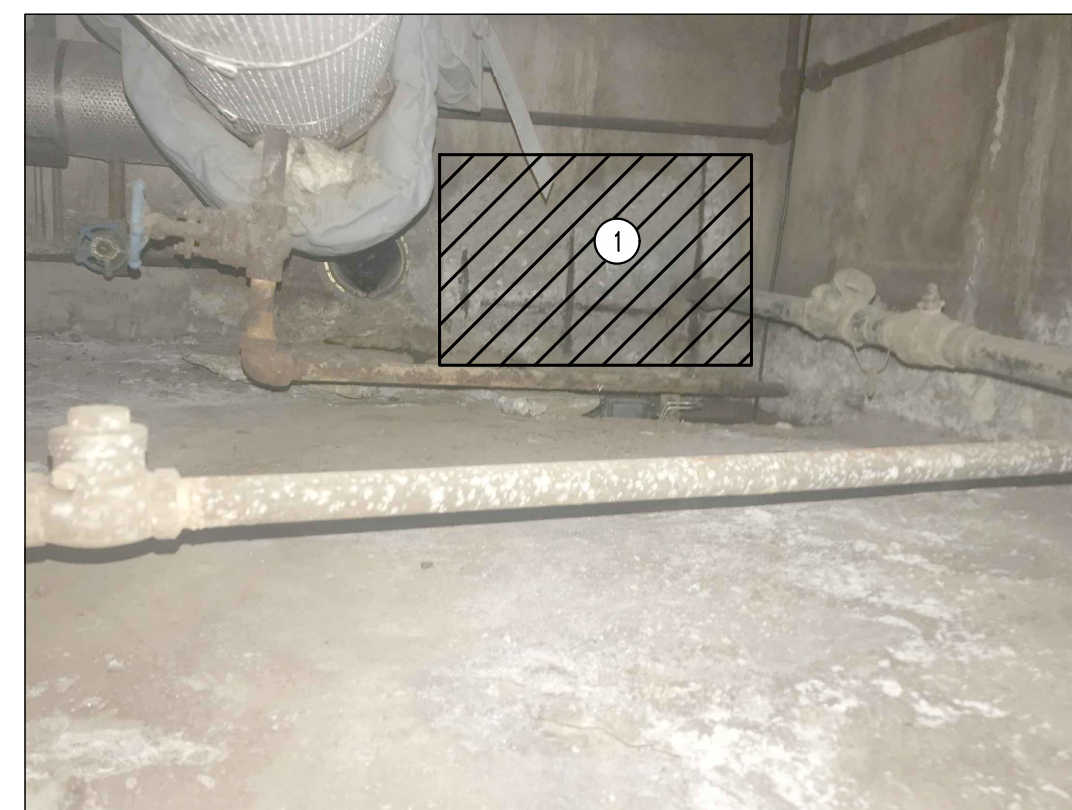
1 SPALLED CONCRETE, SEE REPAIR NOTE 6.

- 24"x36" SPALLED AREA ON WEST WALL (REPAIR #2 EXPECTED).

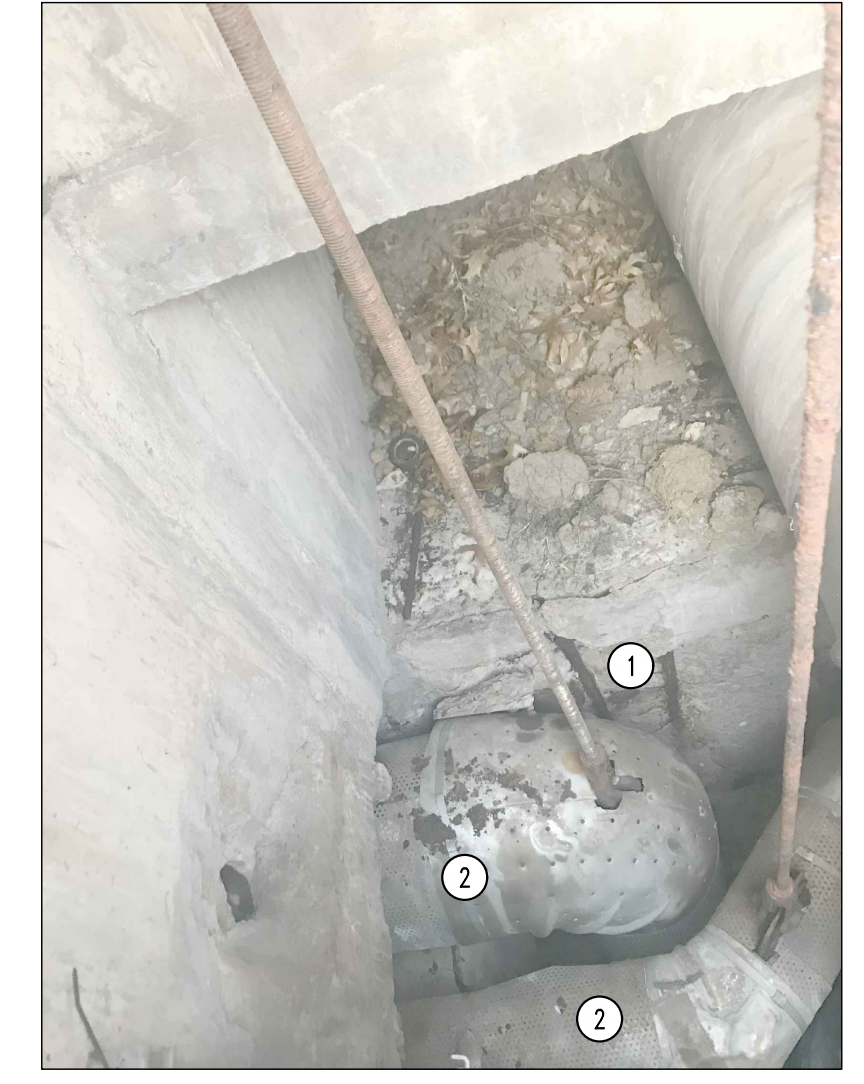
- ① SPALLED CONCRETE, SEE REPAIR NOTE 1.
- ② PIPE TO BE REMOVED BY OWNER.

- SMH #603 APPROXIMATE REPAIR AREAS
- WEST WALL 5'-0" x 5'-0" AREA 3" DEEP, NEW PATCH CAN'T EXTEND PAST FACE OF ORIGINAL CONCRETE DUE TO TIGHT CONDITIONS WITH EXISTING STEAM LINES TO BE REINSTALLED.
  - CORNER OF CHASE TO NORTH 1'-0" x 4'-0" LONG AREA 3" DEEP.
  - (2) SMALL WATER LEAKS SHALL BE INJECTED w/ INJECTABLE WATERSTOP SEAL GUARD II OR PRIOR APPROVED EQUAL.

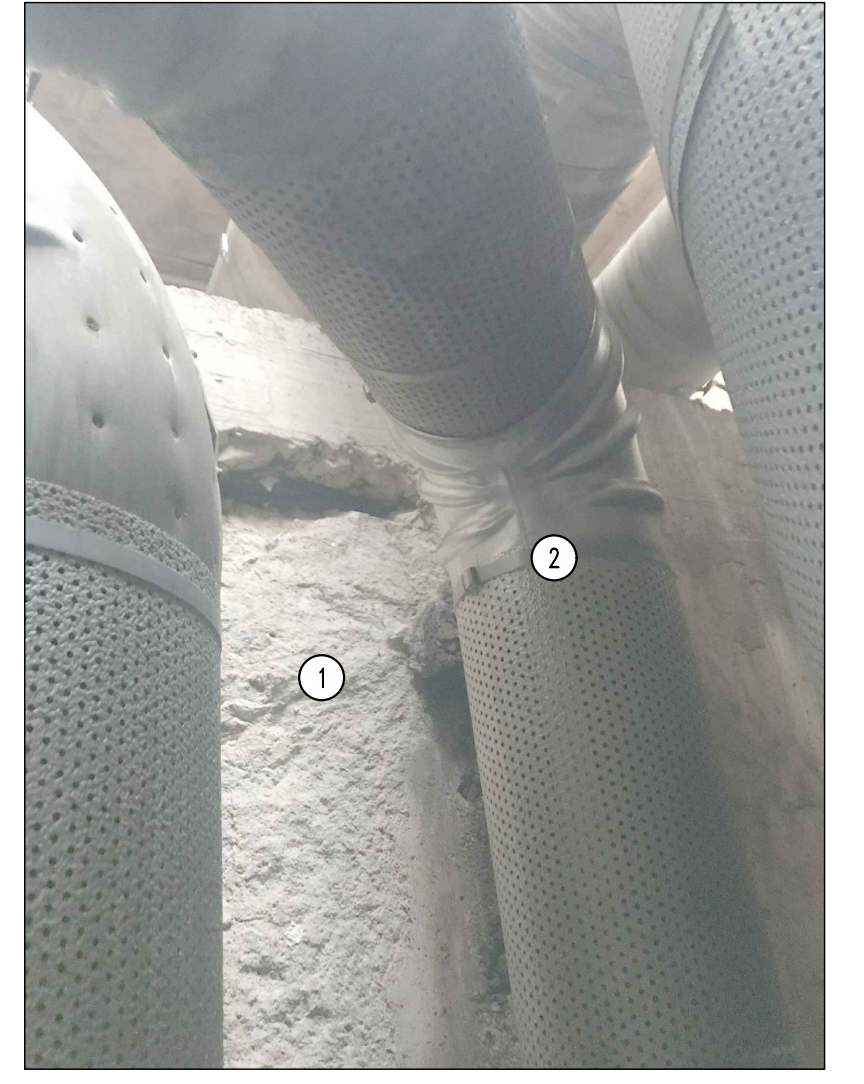
- ① SPALLED CONCRETE, SEE REPAIR NOTE 1.
- ② PIPE TO BE REMOVED BY OWNER.

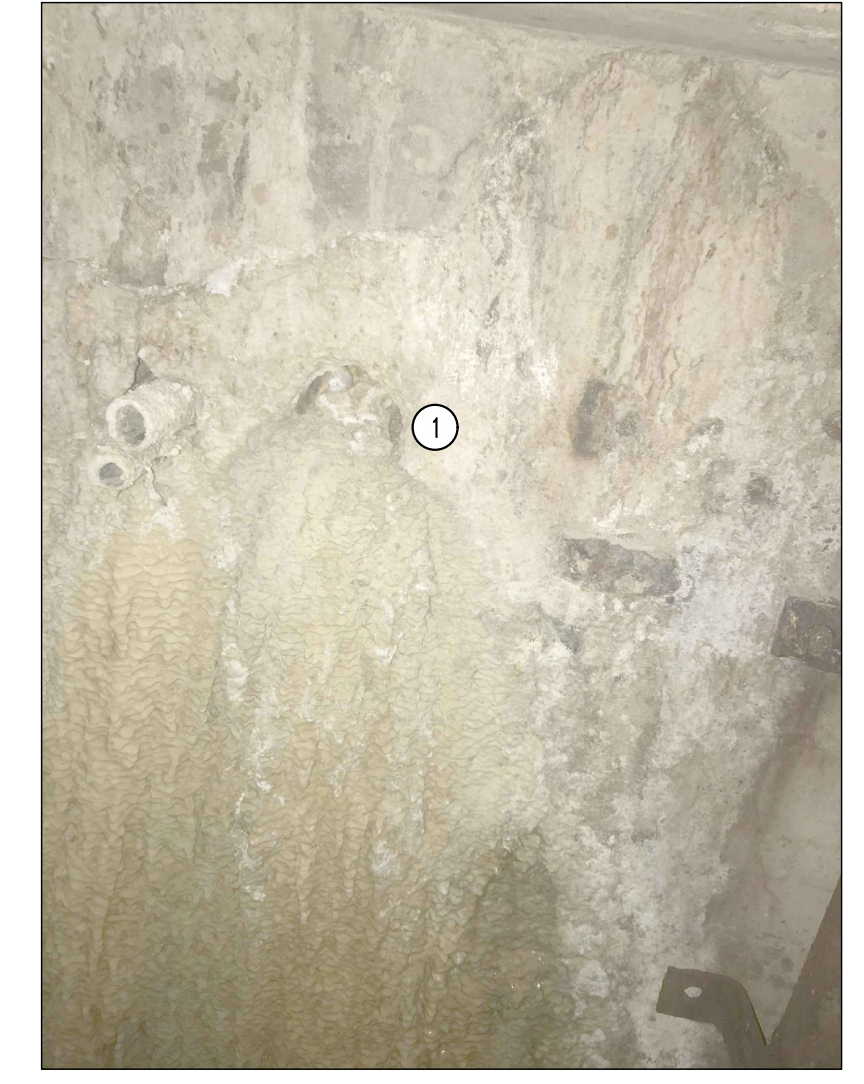
- ① WATER LEAK, SEE REPAIR NOTE 3.

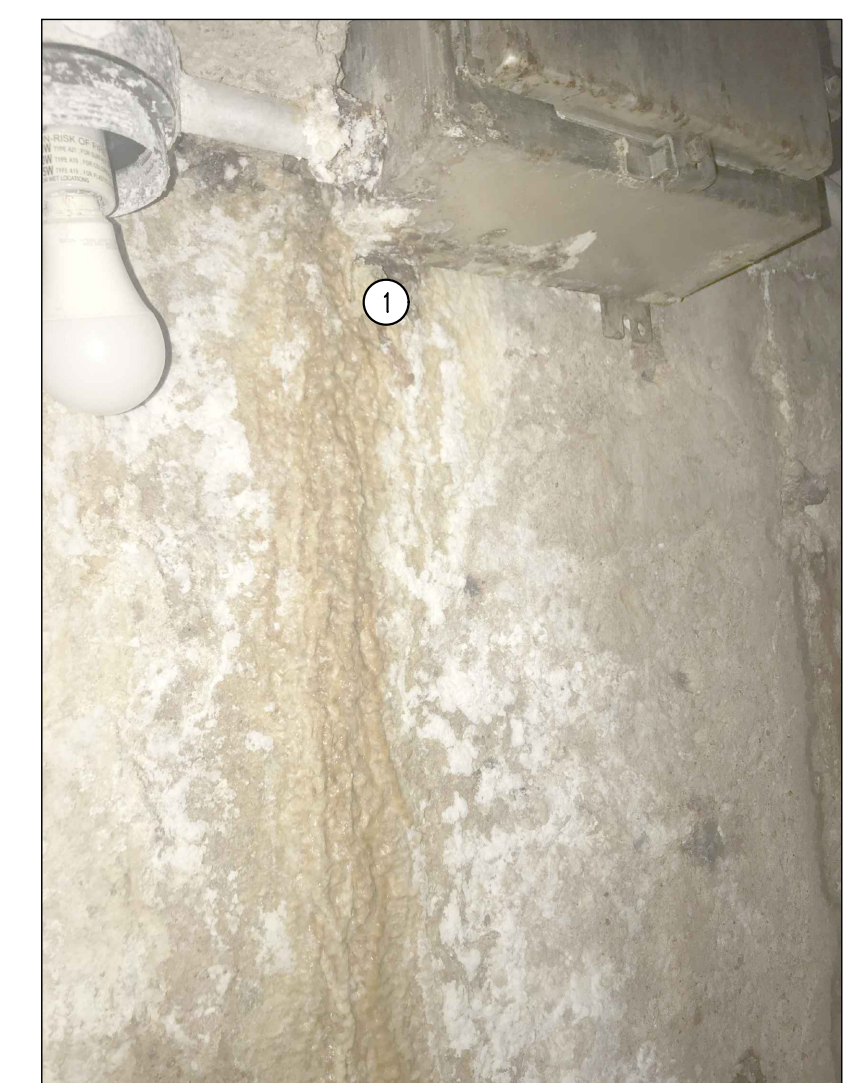
- ① WATER LEAK, SEE REPAIR NOTE 3.

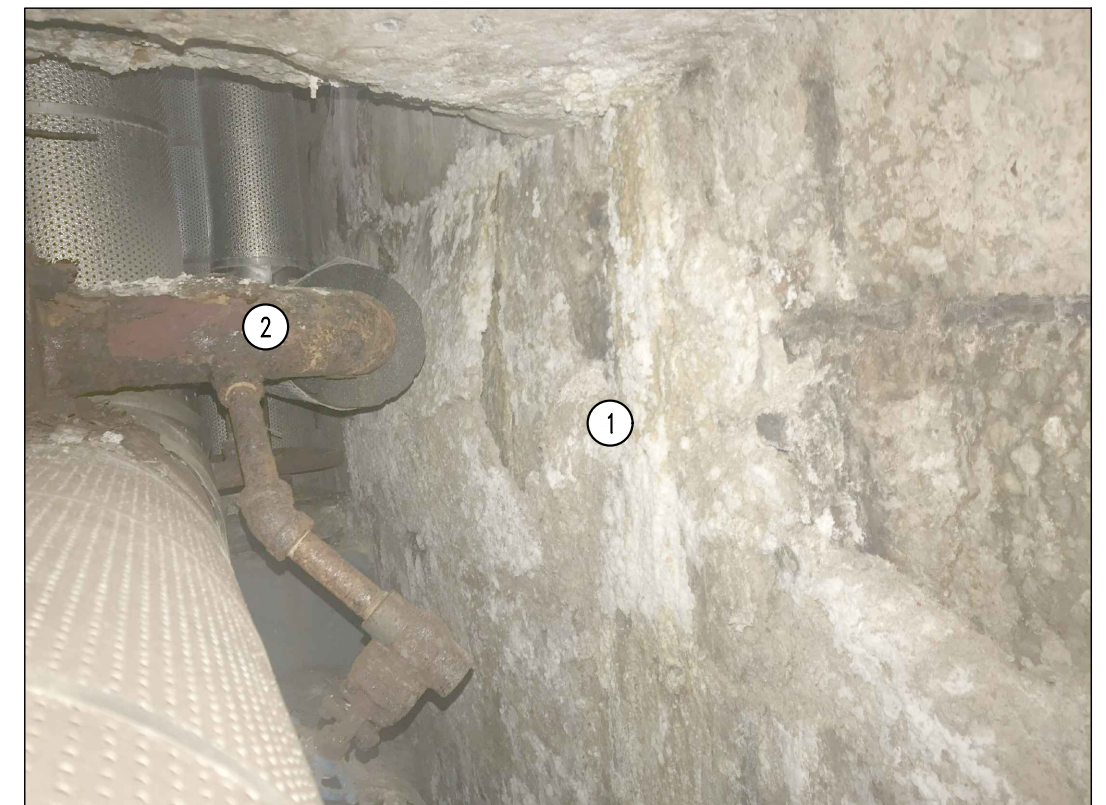
- ① SPALLED CONCRETE, SEE REPAIR NOTE 1.
- ② PIPE TO BE REMOVED BY OWNER.

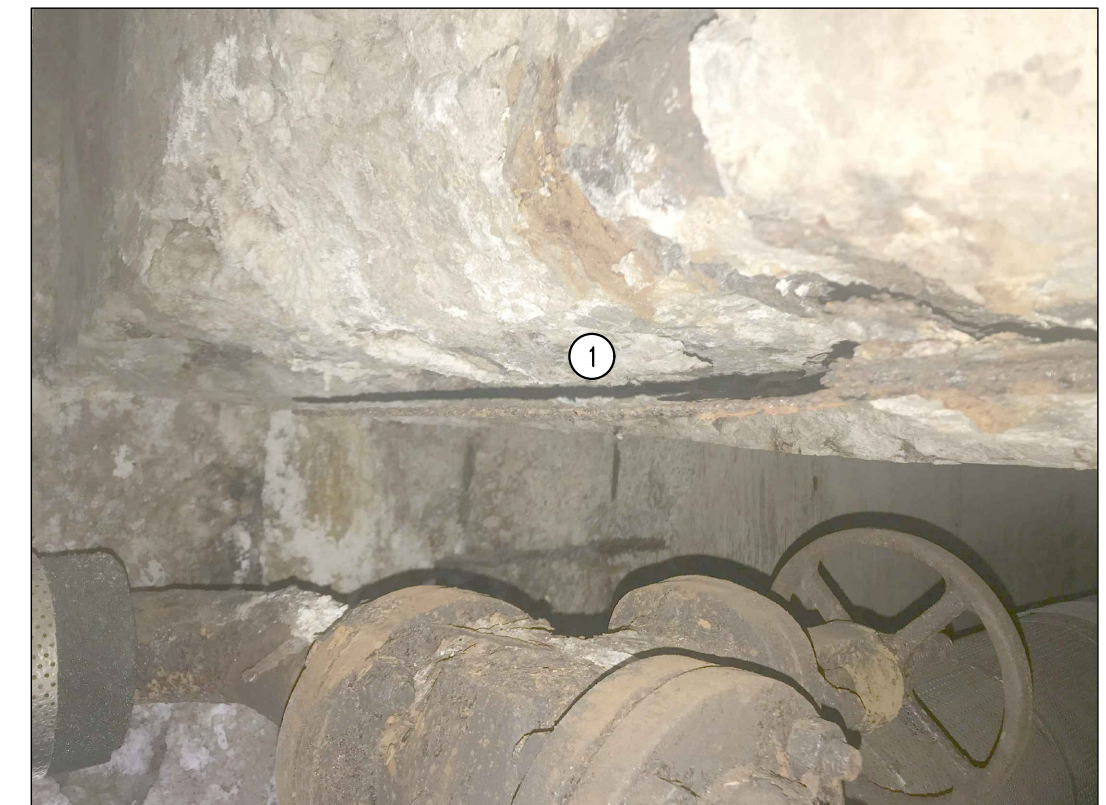
- ① SPALLED CONCRETE, SEE REPAIR NOTE 2.

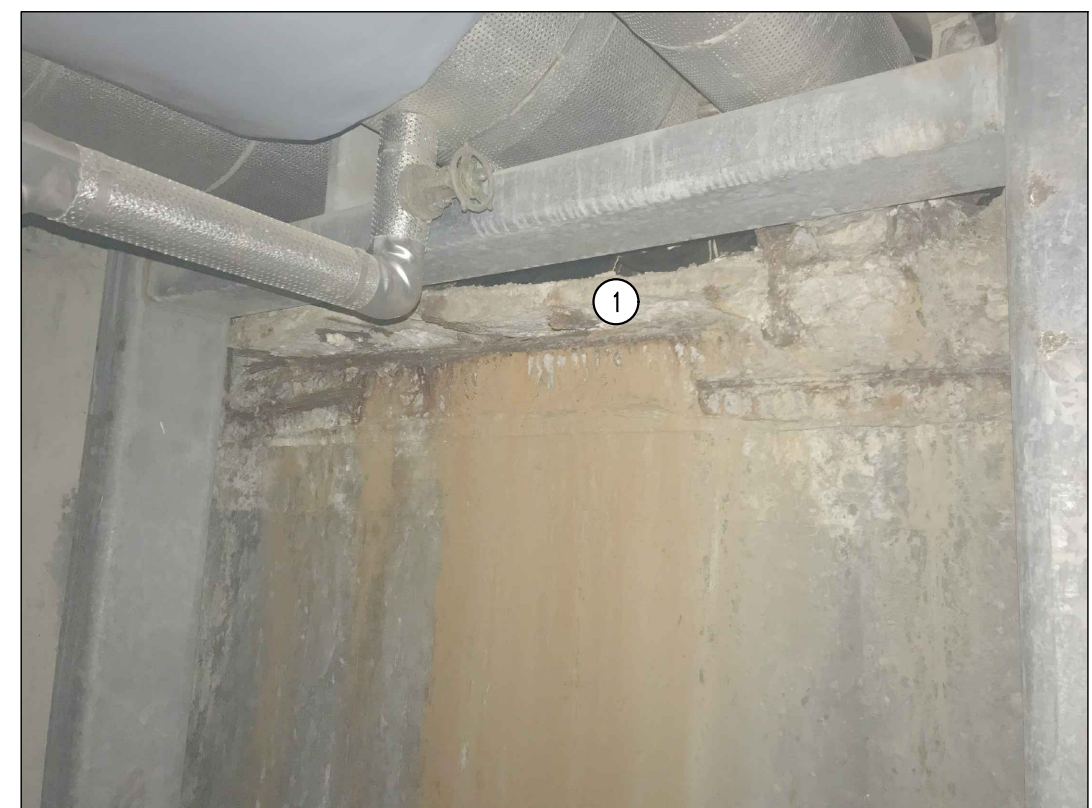
**1** SPALLED CONCRETE, SEE REPAIR NOTE 1.

- BOTH CHASES HAVE SPALLED 6 INCHES THICK X 48 INCHES LONG X 6 INCHES DEEP. (REPAIR #3 EXPECTED)
- (2) EXISTING HSS COLUMNS REQUIRE NEW BASEPLATES. SEE DETAIL 3/S205. PRIOR TO REPAIR, STEAM SYSTEM WILL NEED TO BE SHUT DOWN TO WORK ON THIS ELEMENT, STEAM LINES WILL ONLY BE ABLE TO BE SHUT DOWN ONE AT A TIME AND ANCHORS WILL ONLY BE ABLE TO BE REPLACED ONE AT A TIME. CONTRACTOR SHALL COORDINATE WITH OWNER ONE WEEK IN ADVANCE FOR SYSTEM SHUT DOWN. ADDITIONALLY, NEW EXPANSION ANCHORS INTO LID ARE REQUIRED WHERE ONES HAVE NOT BEEN INSTALLED. USE SAME ANCHORS AS IN BASEPLATE DETAIL. CONTRACTOR PROVIDE VERTICAL PIPE SUPPORT PRIOR TO REPAIR. REPAIR DELAMINATION BEHIND LADDER.
- THERE ARE A TOTAL OF 4 FEET OF CRACKS THAT WILL NEED TO BE EPOXY INJECTED WITH SIKADUR INJECTION GEL OR APPROVED EQUAL.

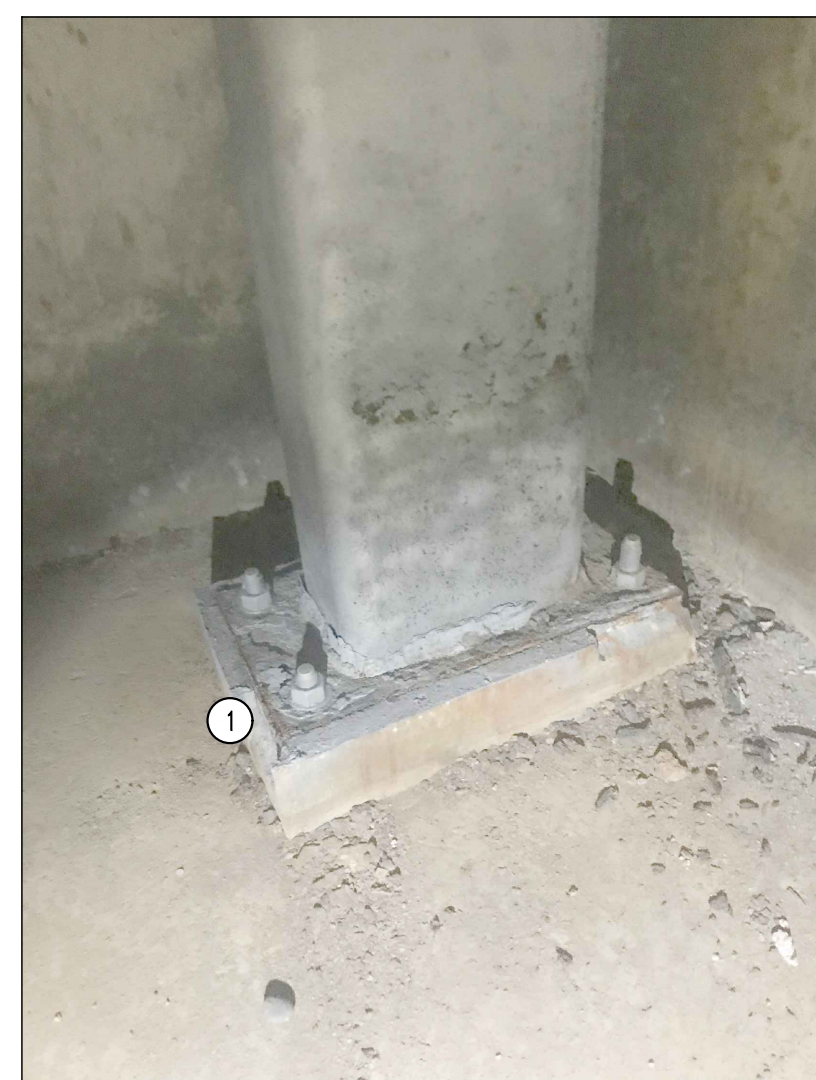
**1** DAMAGED BASE PLATE, SEE REPAIR NOTE 2.
