# University of Missouri For The Curators of the University of Missouri MU Project number CP220041 Advertisement Date: January 18, 2022 Various Locations - Repair Concrete in Steam Manholes

**CP220041 - VARIOUS LOCATIONS  
REPAIR CONCRETE IN STEAM MANHOLES**  
**UNIVERSITY OF MISSOURI  
COLUMBIA, BOONE COUNTY, MISSOURI**

DRAWING INCLUDES:  
 SMH #023  
 PLAN & PHOTOS

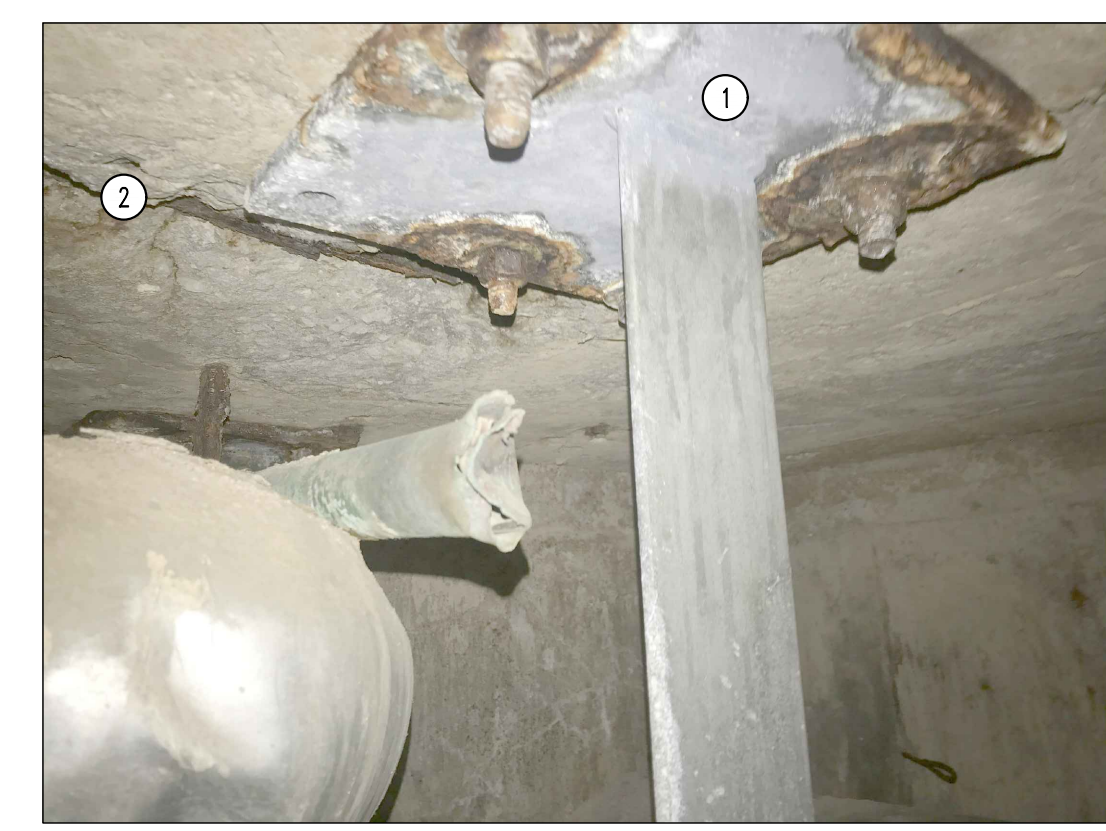
- 1 CAP PLATE DAMAGE, SEE REPAIR NOTE 4.
- 2 EXPOSED REBAR, SEE REPAIR NOTE 1.

- SMH #004 APPROXIMATE REPAIR AREAS**
1. IN THE LID THERE IS REBAR EXPOSED, APPROX. 2'-0" x 4'-0". (REPAIR #3 EXPECTED)
  2. CONCRETE AROUND PIPE PENETRATIONS (2 TOTAL) IN THE NORTH AND EAST WALL, 6" @ PERIMETER (REPAIR #2 EXPECTED)
  3. SPALLING AT AND AROUND LID, 12" ALL SIDES (REPAIR #3 EXPECTED)
  4. SPALLED CONCRETE AT EXISTING CAP PLATE (36"x36") (EXPECT REPAIR #2), REPAIR CAP PLATE & BASE PLATE SEE "BP-3" @ DETAIL 2/S206. COORDINATE STEAM SHUT DOWN WITH OWNER PRIOR TO REPAIR.
  5. 6"x24" SPALL REPAIR AT CENTER WALL, (REPAIR #3 EXPECTED)
  6. 24"x24" STEEL PLATE AT SOUTH WALL TO BE REMOVED AND CONCRETE REPAIRED, (FULL DEPTH REPAIR EXPECTED)

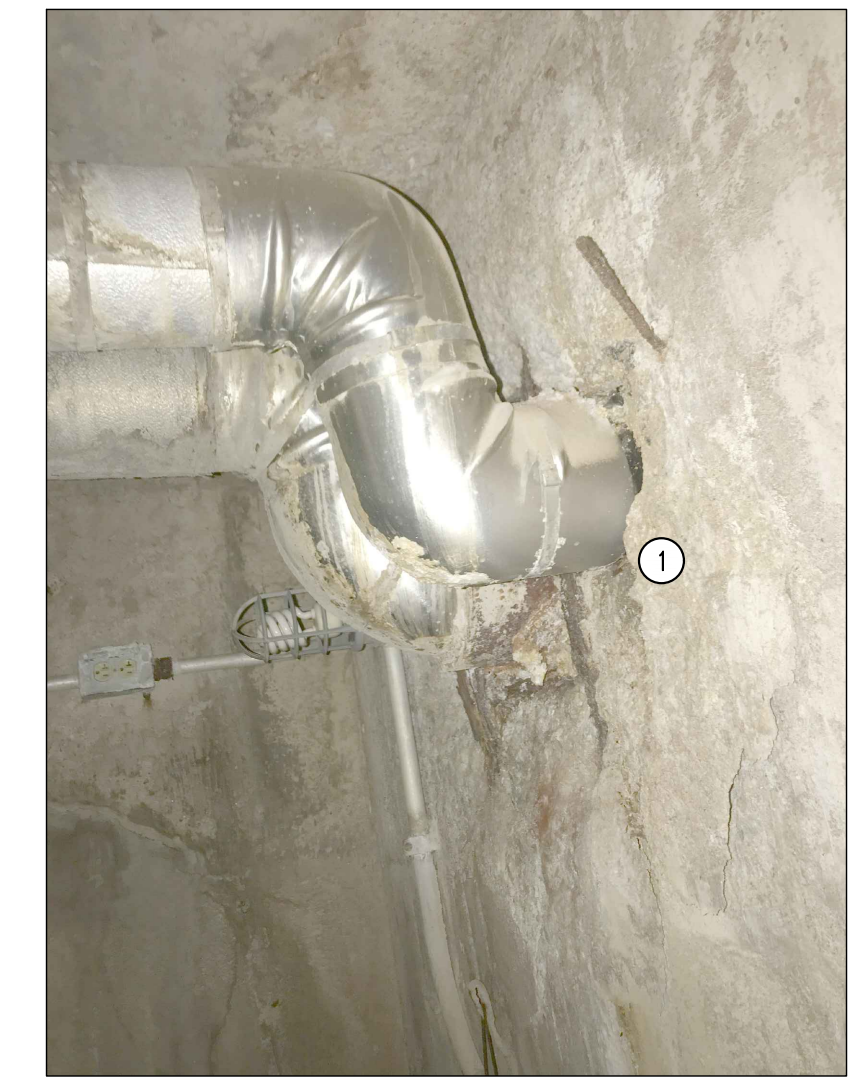
- 1 SPALLING, SEE REPAIR NOTE 2.

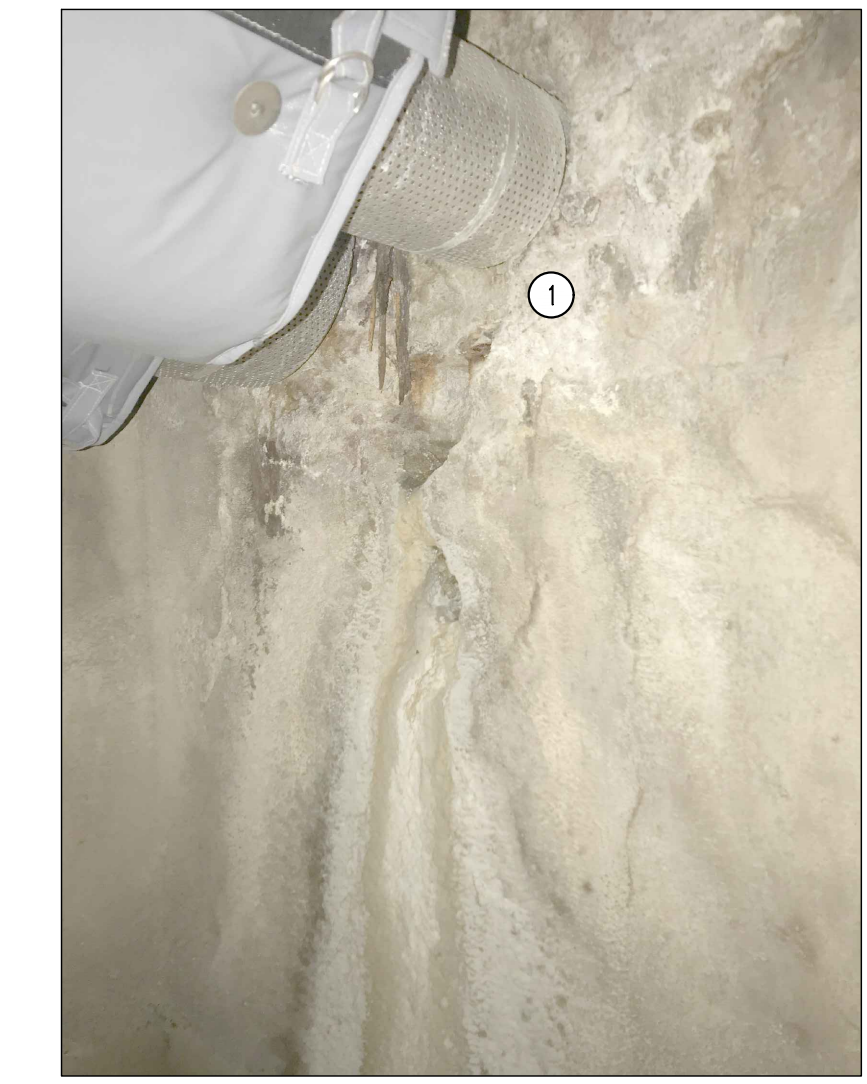
- 1 SPALLING, SEE REPAIR NOTE 2.

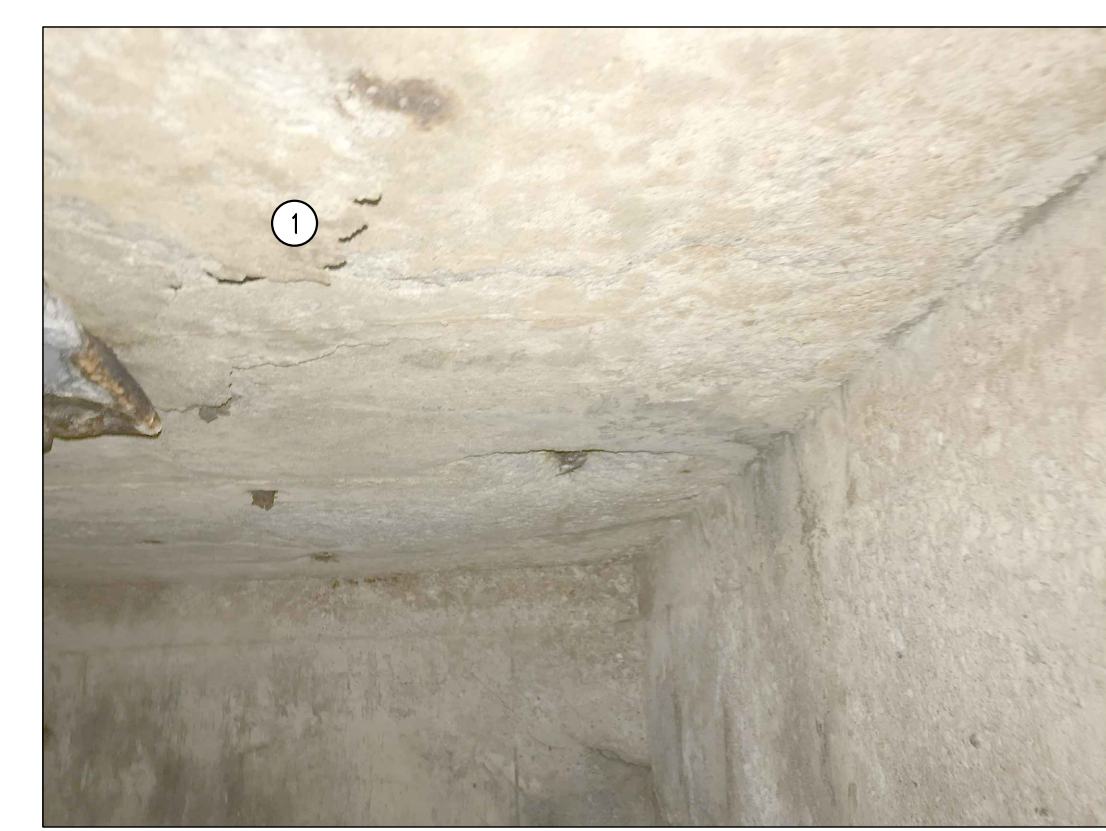
- 1 SPALLED LID, SEE REPAIR NOTE 1.

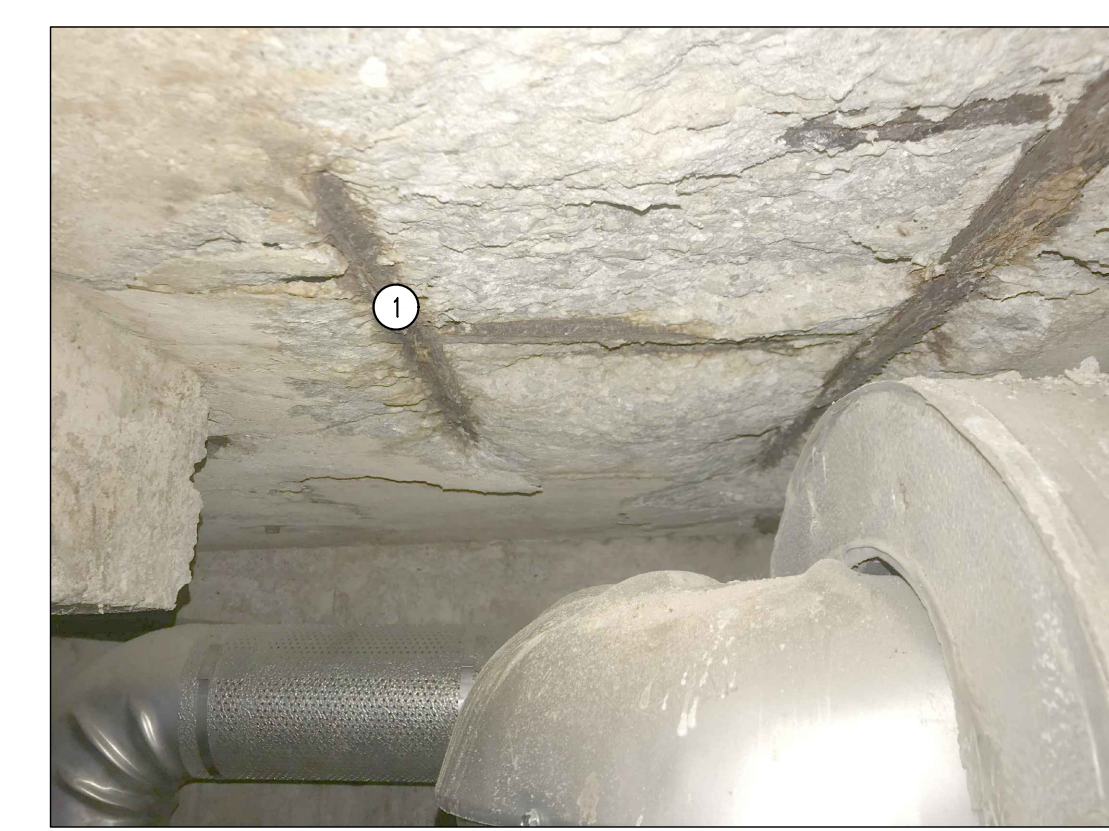
- 1 EXPOSED REBAR, SEE REPAIR NOTE 3.

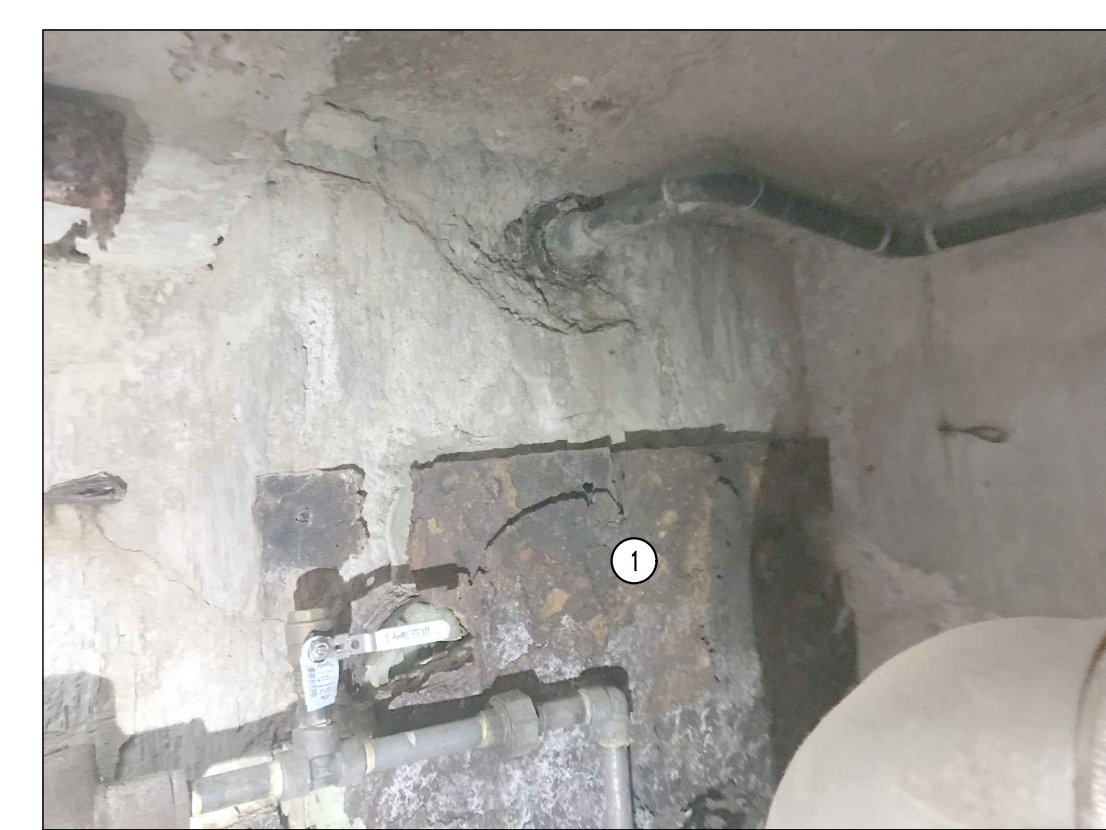
- 1 STEEL PLATE, SEE REPAIR NOTE 6.

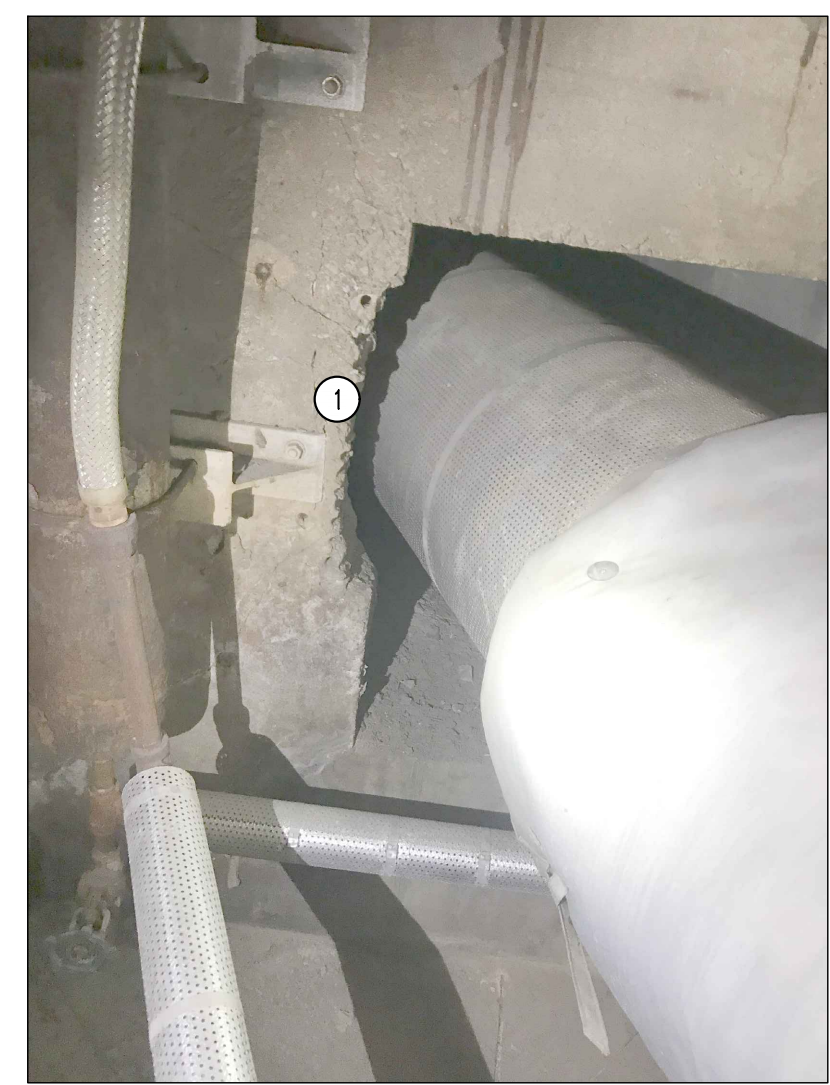
① SPALLED CONCRETE, SEE REPAIR NOTE 2.

- REPAIR NOTES**
- SMH #634 APPROXIMATE REPAIR AREAS
- NEAR THE LADDER THERE IS 48"x48" SPALLING X 1 INCH DEEP. (REPAIR #1 EXPECTED)
  - AROUND THE CHASE THERE IS REBAR EXPOSED AND 48"x4" SPALLING X 3 INCH DEEP. (REPAIR #3 EXPECTED)

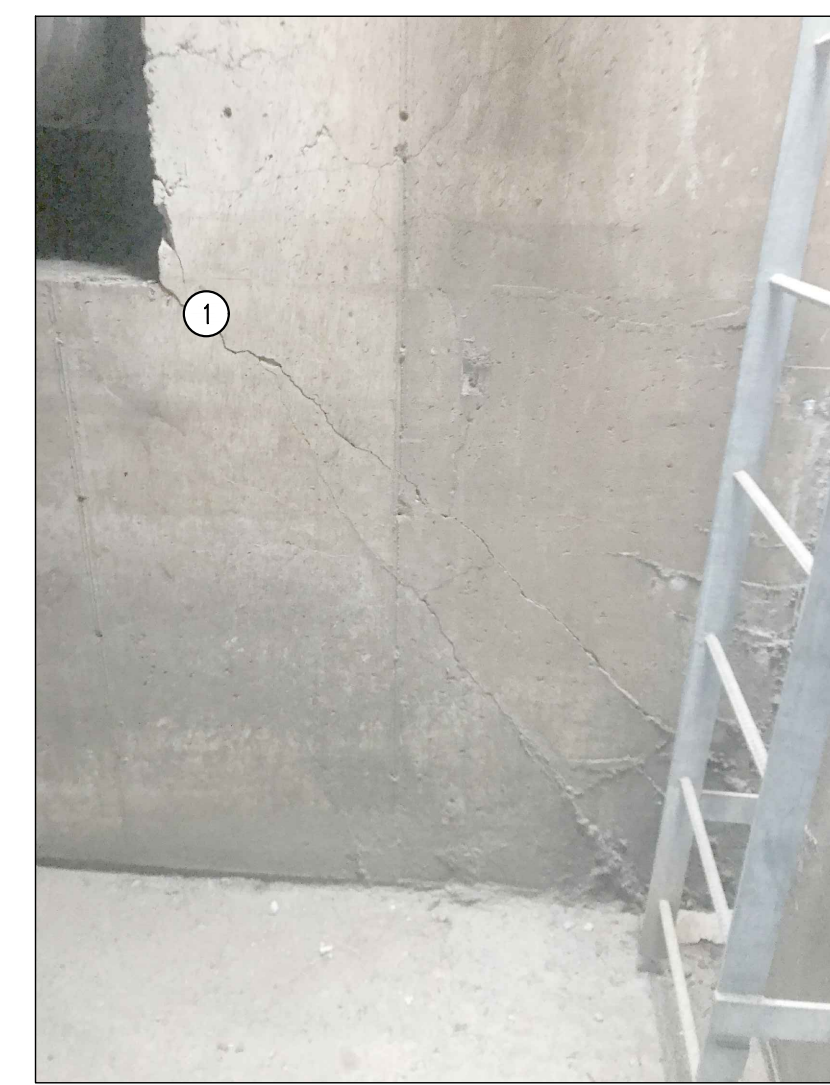
① SPALLED CONCRETE, SEE REPAIR NOTE 2.

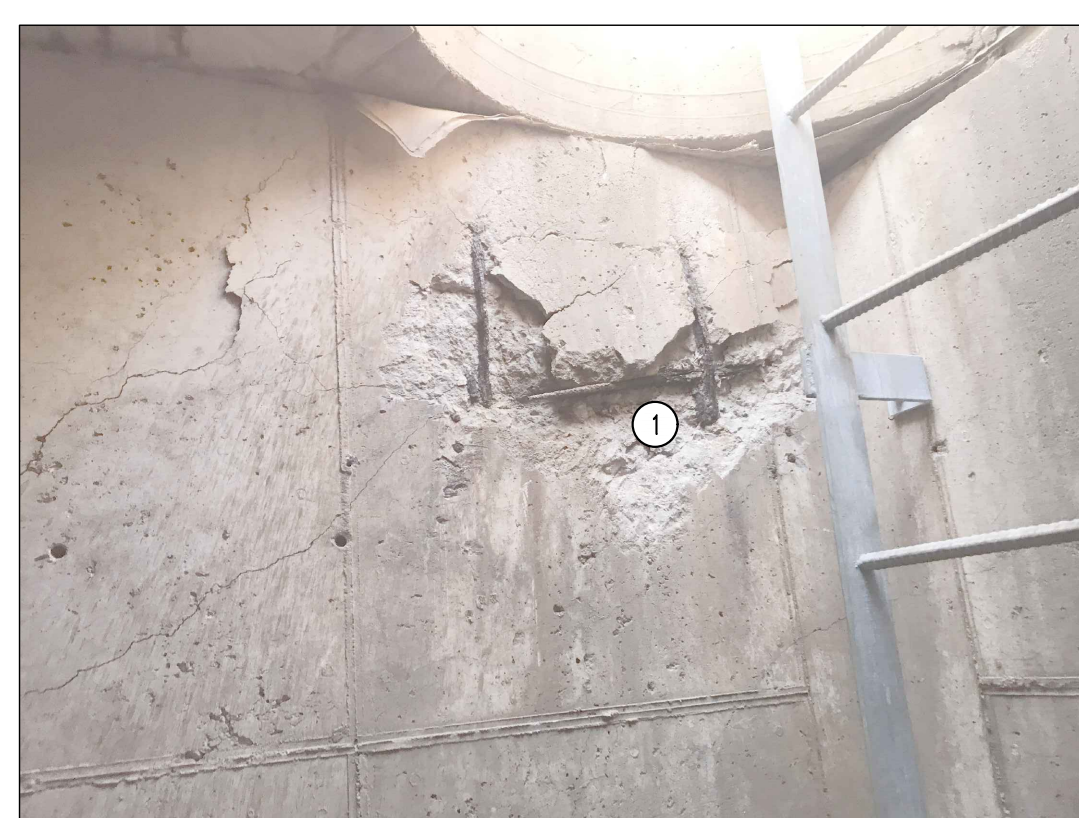
① SPALLED CONCRETE, SEE REPAIR NOTE 1.
