The Curators of the University of Missouri MU Project number CP240081 Advertisement Date: January 18, 2024 Various Locations - Repair Concrete in Steam Manholes

### Columbia, Boone County, Missouri

SMH #338 PLAN & PHOTOS

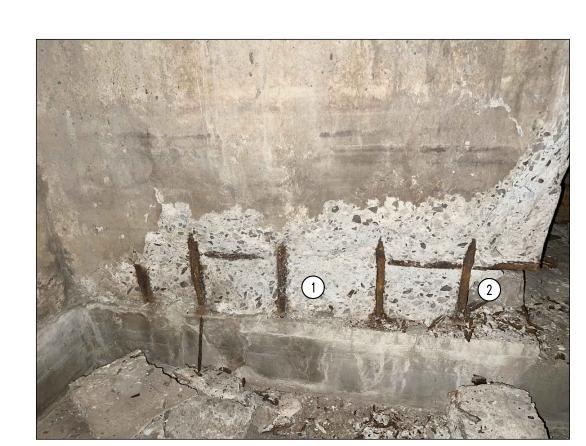
SMH #338 - TIGER AVENUE

- 1 EXPOSED REBAR, SEE REPAIR NOTE 1.
- 2 1'-0"x1'-0" FULL DEPTH REPAIR, SEE DETAIL ON SHEET S200.
  EXCAVATING IS REQUIRED OUTSIDE OF MANHOLE FOR REPAIR.
  APPLY WATERPROOFING TO REPAIR AREA, REFER TO WATERPROOFING DETAIL ON SHEET S200

- 1. 18"x3'-6" AREA OF EXPOSED REBAR ON NORTH WALL NEXT TO CHASE. (REPAIR #2)
- 2. SPALLED CONCRETE ON THE SOUTH WALL EAST SIDE NEXT TO CHASE, 0'-6"x2'-0" AREA. (REPAIR #2)

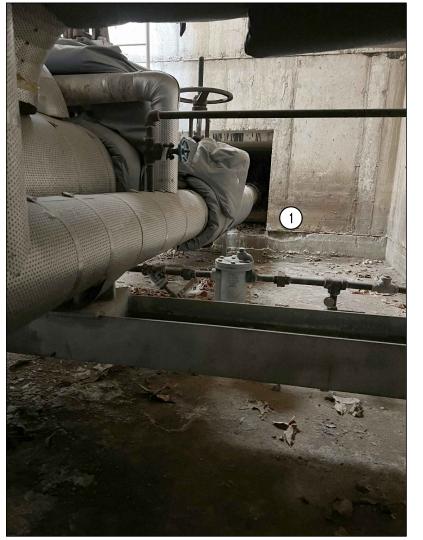
SMH #338 - TIGER AVENUE

1) SPALLED CONCRETE, SEE REPAIR NOTE 2.

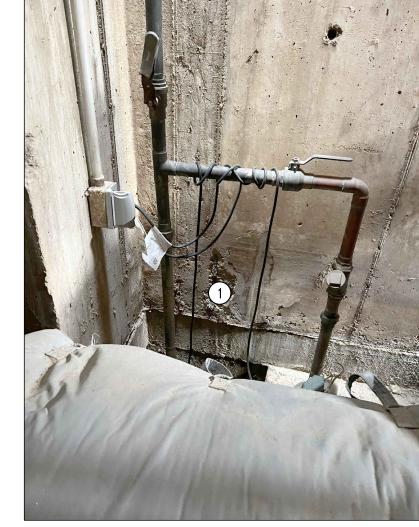
SMH #338 - TIGER AVENUE

1) SPALLED CONCRETE, SEE REPAIR NOTE 3.

3. SPALLED CONCRETE WEST WALL NEXT TO CHASE, 2'-0"x2'-0" AREA. (REPAIR #2)
- 4. DEEP SPALL ON WEST WALL UNDER CHASE, 1'-0"x1'-0" AREA (2 TOTAL). (REPAIR #3)

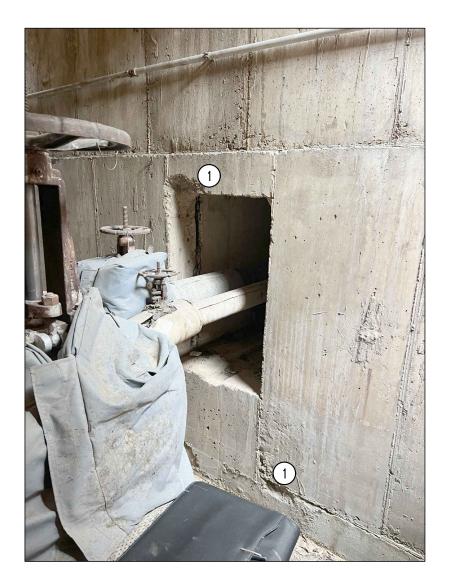
SMH #338 - TIGER AVENUE

1) SPALLED CONCRETE, SEE REPAIR NOTE 4.

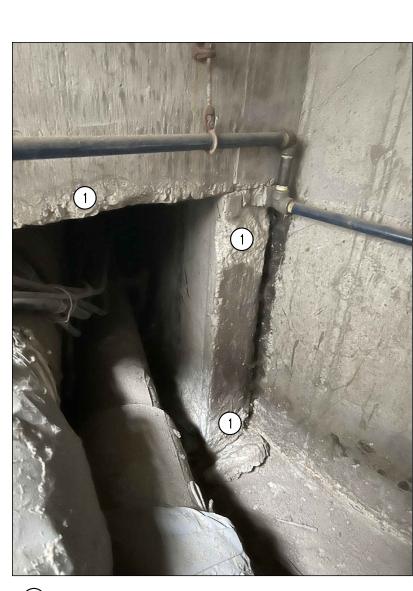
SMH #024 - CONLEY AVE.

1) SPALLED CONCRETE, SEE REPAIR NOTE 2.

1. 4'-0"x6'-0" SPALLED AREA EAST WALL. (REPAIR #2) 2. SPALLED AREA AROUND CHASE. (REPAIR #2)

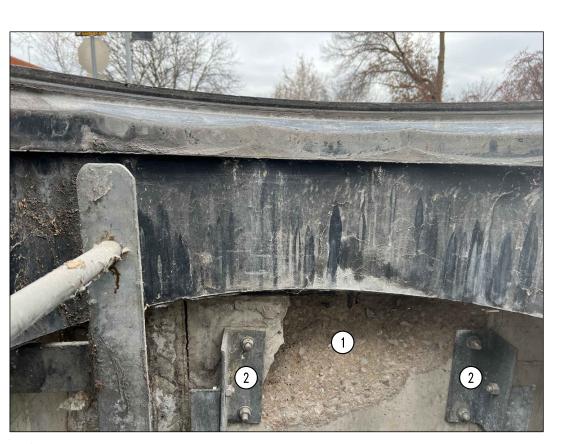
SMH #710 - CONLEY AVE.

1. SPALLED AREA IN RISER. (REPAIR #3)

1) SPALLED CONCRETE, SEE REPAIR NOTE 1.

2) REMOVE MANHOLE SECURITY GATE PRIOR TO REPAIR, REINSTALL ONCE REPAIR IS COMPLETE.

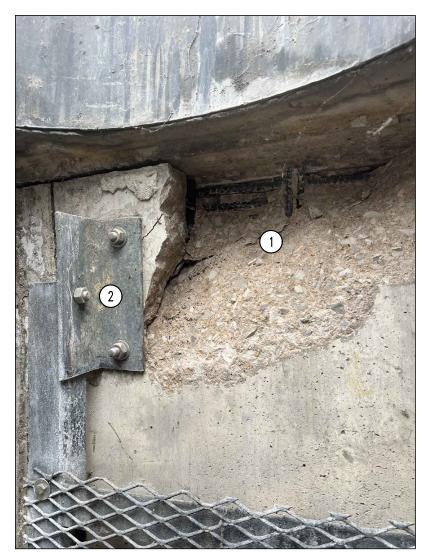
SMH #710 - CONLEY AVE.

1) SPALLED CONCRETE, SEE REPAIR NOTE 1.

2 REMOVE MANHOLE SECURITY GATE PRIOR TO REPAIR, REINSTALL ONCE REPAIR IS COMPLETE.

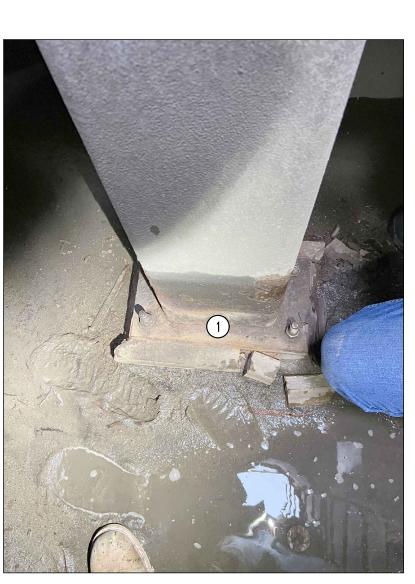
SMH #369 - HOSPITAL DR.

1 DAMAGED BASE PLATE, SEE REPAIR NOTE 1.

1. (4) EXISTING HSS COLUMNS REQUIRE NEW BASEPLATES. SEE DETAIL 2/S102. PRIOR TO REPAIR, STEAM SYSTEM WILL NEED TO BE SHUT DOWN TO WORK ON THIS ELEMENT, STEAM LINES WILL ONLY BE ABLE TO BE SHUT DOWN ONE AT A TIME AND ANCHORS WILL ONLY BE ABLE TO BE REPLACED ONE AT A TIME. CONTRACTOR SHALL COORDINATE WITH OWNER ONE WEEK IN ADVANCE FOR SYSTEM SHUT DOWN. REMOVE TEMPORARY BRACING ONCE NEW BASE PLATES ARE INSTALLED. ADDITIONALLY, ALL RUST ON COLUMNS SHALL BE REMOVED & SHALL BE HOT GALV. FINISHED.

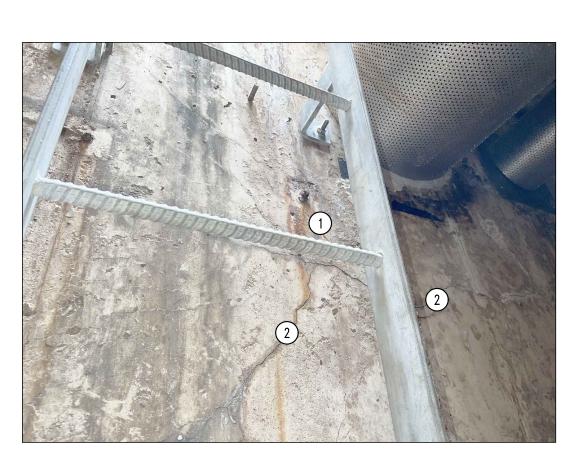
SMH #140 - ROLLINS ST.

1) SPALLED CONCRETE, SEE REPAIR NOTE 1. 2 CONCRETE CRACKING, SEE CRACK REPAIR DETAIL ON SHEET S200.

1. 18" HIGH  $\times$  3' LONG SPALLED CONCRETE BEHIND LADDER. (REPAIR #3) 2. EXPOSED REBAR ON ROOF UNDER RISER, 2'-0"x2'-0" AREA. (REPAIR #2)

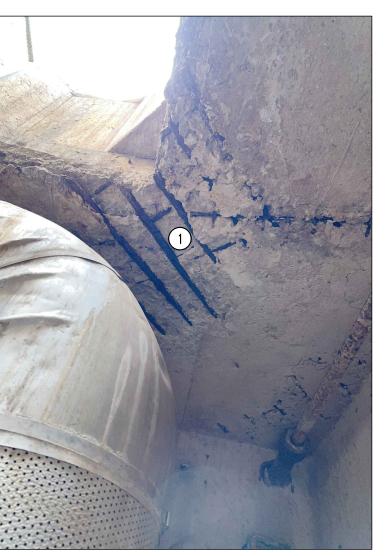
SMH #140 - ROLLINS ST.

1) EXPOSED REBAR, SEE REPAIR NOTE 2.

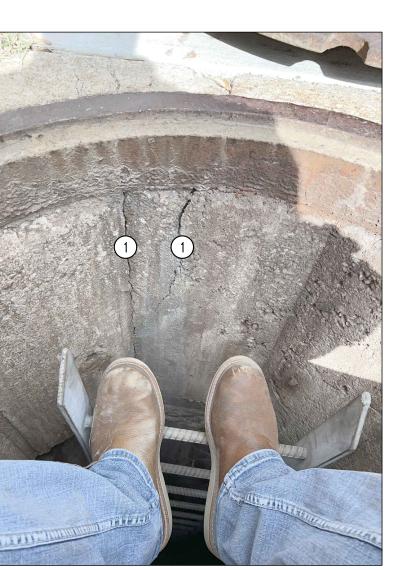
SMH #140 - ROLLINS ST.

1) CONCRETE CRACKING, SEE REPAIR NOTE 3.

3. 18" STRIP 2" TALL CRACKING IN RING. (REPAIR #4)

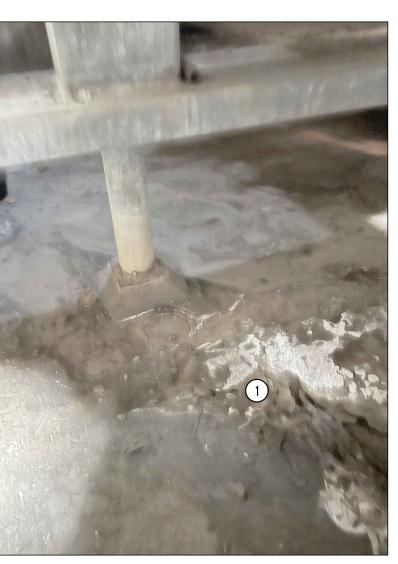
SMH #313 - HITT ST.

1) SPALLED CONCRETE, SEE REPAIR NOTE 2.

- 1. CRACKING ON NORTH WALL, 10 LINEAR FEET. (REPAIR #4)
- 2. 18"x18" SPALLED AREA ON FLOOR. (REPAIR #3)
- 3. SPALLED CONCRETE ON LID, 4'-0"x4'-0" AREA. (REPAIR #3)

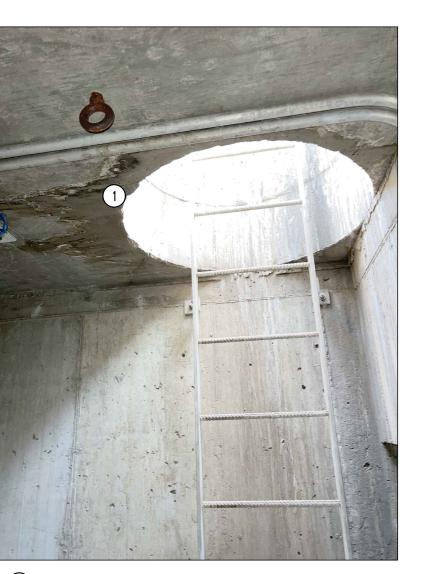
SMH #313 - HITT ST.

1) SPALLED CONCRETE, SEE REPAIR NOTE 3.

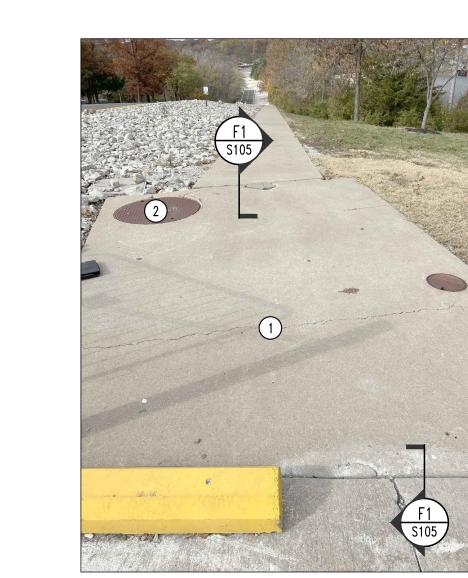
1 REPLACE SIDEWALK, SEE REPAIR NOTE 2.
2 REPLACE EXISTING LID w/ NEW FIBRELITE LID.

- 1. AREA UNDER CHASE 6'-0"x2'-0"x0'-3" TALL. (REPAIR #3 EXPECTED)
- 2. REPLACE SIDEWALK ABOVE STEAM MAN HOLE, 15'-0"x10'-0" w/ 5" SLAB w/ 6x6 W2.9xW2.9WWF.
- w/ 6x6 WZ.9xWZ.9WWF.
- 3. AROUND THE CHASE THERE ARE CRACKS NEEDING INJECTED, APPROX. 10 LINEAR FEET. (REPAIR #4)
- 4. SPALLED AREA 12"x24" ABOVE CHASE. (REPAIR #2)
- 5. VERTICAL CRACK PRESENT IN RISER, APPROX. 2 LINEAR FEET. (REPAIR #4)

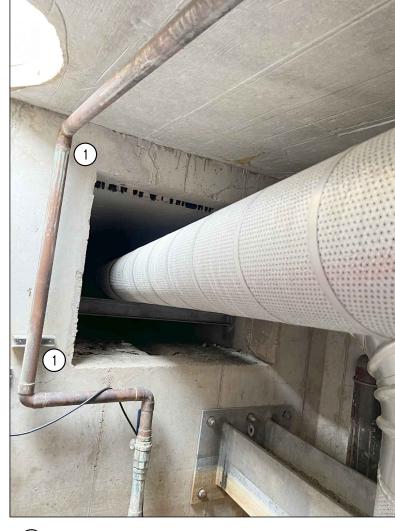
#### SMH #638 - CHAMPIONS DR.

1) SPALLED CONCRETE, SEE REPAIR NOTE 3.

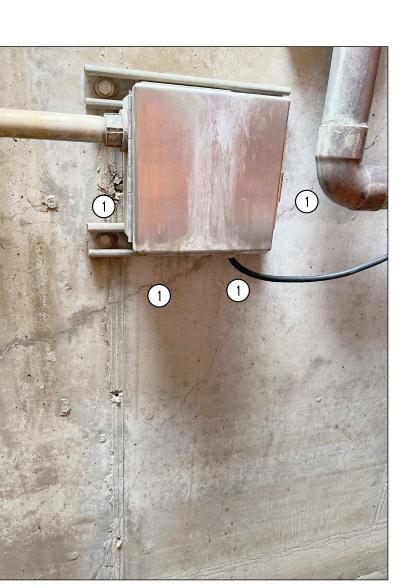
SMH #638 - CHAMPIONS DR.

1 CONCRETE CRACKING, SEE CRACK REPAIR DETAIL ON SHEET S200.

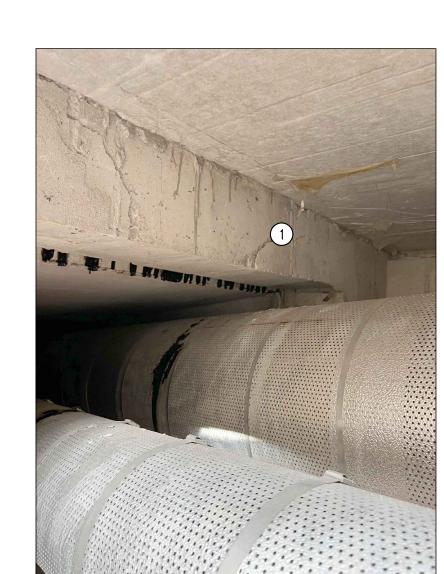
SMH #638 - CHAMPIONS DR.

1) DEAD SPOT UNDER CHASE, SEE REPAIR NOTE 1.

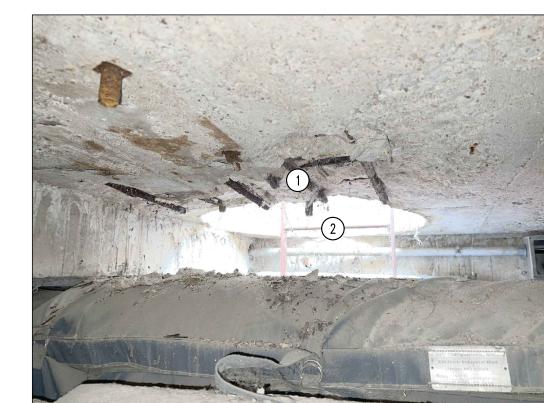
#### SMH #310 - JOHNSTON HALL

- 1) REBAR EXPOSED, SEE REPAIR NOTE 1.

- 1. EXPOSED REBAR ON ROOF, APPROX. 2'-0"x3'-0" AREA. (REPAIR #2)
- 2.18"x 6'-0" AREA CRACKING NORTH WALL EAST SIDE. (REPAIR #4)
- 3. SPALLING ON ENTIRE LID. (REPAIR #2 AND/OR REPAIR #3) 4. SPALLING AROUND CHASE, APPROX. 1'-0"x3'-0" AREA. (REPAIR #3)

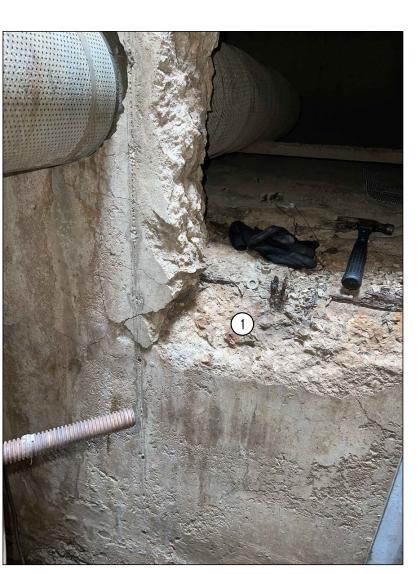
1) SPALLED CONCRETE, SEE REPAIR NOTE 4.

- 2 LADDER DOES NOT MEET CODE, REMOVE AND REPLACE.

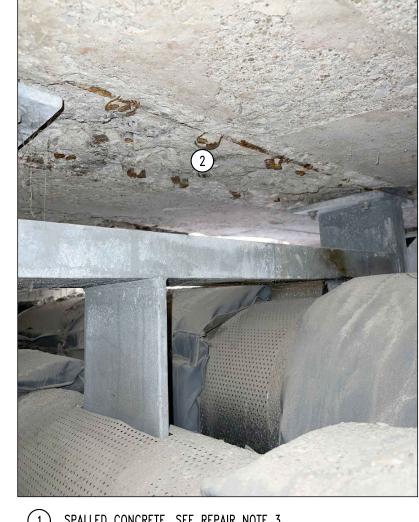
SMH #310 - JOHNSTON HALL

- 1) SPALLED CONCRETE, SEE REPAIR NOTE 3.
- 2 COAT EXISTING REBAR REBAR W/ UNDERCOATING TO PREVENT CORROSION.

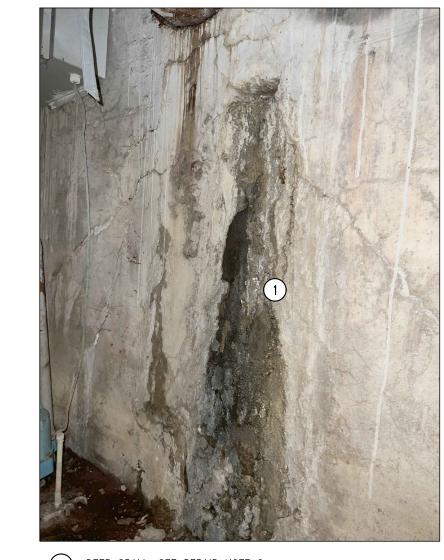
1 DEEP SPALL, SEE REPAIR NOTE 2. SMH #414 - SOUTH COLLEGE AVE.

- 2. SOUTH WALL REPAIR SPALL, 3'-0"x4'-0" AREA. (REPAIR #2) 3. REBAR ANCHORAGE CONCRETE REPAIR, 1'-0"x2'-0" AREA. (REPAIR #2)
- 4. CRACKING ON WALL, 1'-0"x1'-0" AREA. (REPAIR #3)

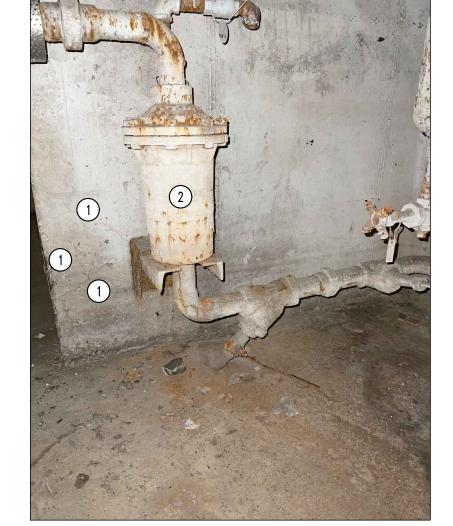
SMH #414 - SOUTH COLLEGE AVE.

1) CONCRETE CRACKING, SEE REPAIR NOTE 4. 2 OWNER TO REMOVE PRIOR TO REPAIRS.
