The Curators of the University of Missouri MU Project number CP240081 Advertisement Date: January 18, 2024 Various Locations - Repair Concrete in Steam Manholes

### Columbia, Boone County, Missouri

SMH #338 PLAN & PHOTOS

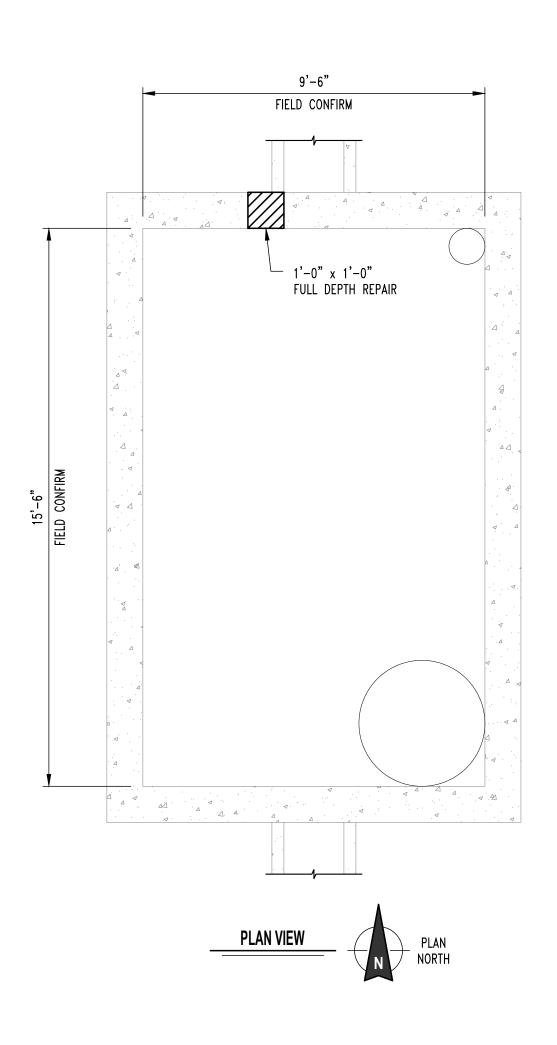
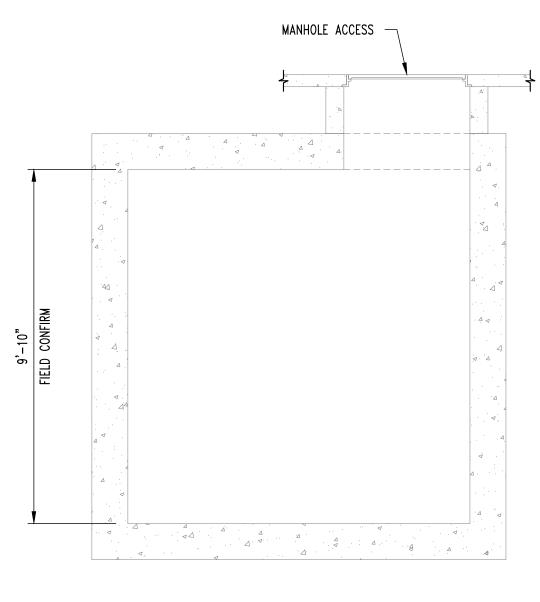
STEAM MANHOLE #338

- 1 EXPOSED REBAR, SEE REPAIR NOTE 1.
- 2 1'-0"x1'-0" FULL DEPTH REPAIR, SEE DETAIL ON SHEET S200.
  EXCAVATING IS REQUIRED OUTSIDE OF MANHOLE FOR REPAIR.
  APPLY WATERPROOFING TO REPAIR AREA, REFER TO WATERPROOFING DETAIL ON SHEET S200

1) SPALLED CONCRETE, SEE REPAIR NOTE 2.

1) SPALLED CONCRETE, SEE REPAIR NOTE 3.

1) SPALLED CONCRETE, SEE REPAIR NOTE 4.

- 1. 18"x3'-6" AREA OF EXPOSED REBAR ON NORTH WALL NEXT TO CHASE. (REPAIR #2)
- 2. SPALLED CONCRETE ON THE SOUTH WALL EAST SIDE NEXT TO CHASE, 0'-6"x2'-0" AREA. (REPAIR #2)

3. SPALLED CONCRETE WEST WALL NEXT TO CHASE, 2'-0"x2'-0" AREA. (REPAIR #2)
- 4. DEEP SPALL ON WEST WALL UNDER CHASE, 1'-0"x1'-0" AREA (2 TOTAL). (REPAIR #3)

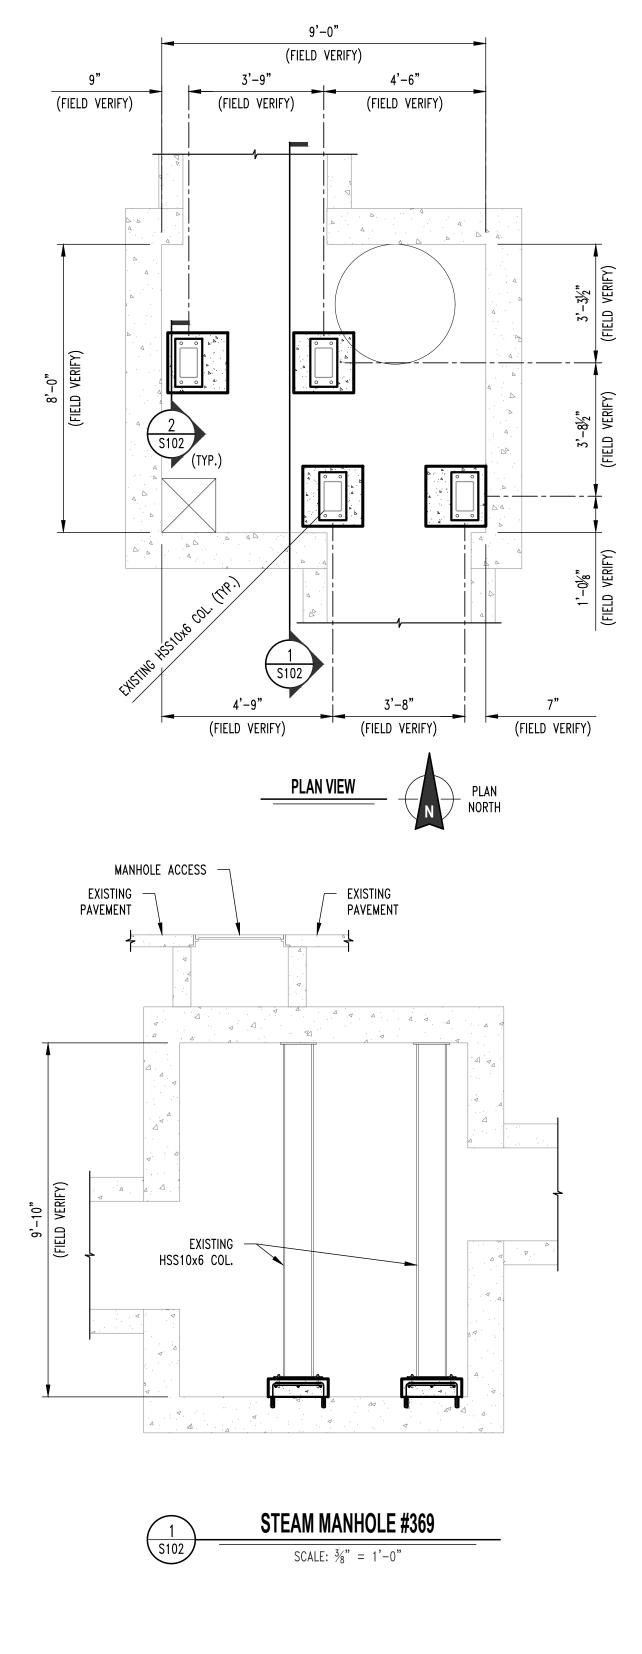
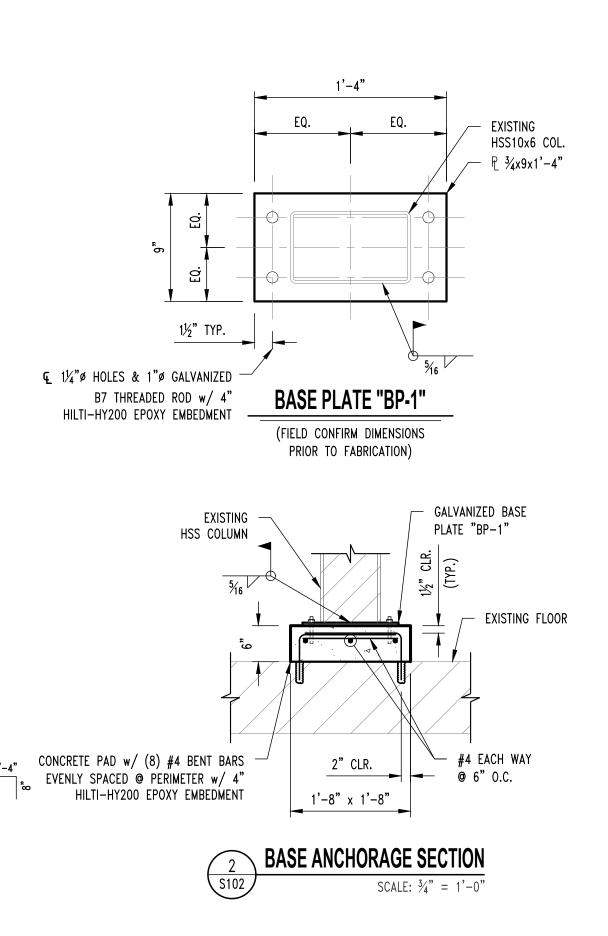
1 DAMAGED BASE PLATE, SEE REPAIR NOTE 1.

1. (4) EXISTING HSS COLUMNS REQUIRE NEW BASEPLATES. SEE DETAIL 2/S102. PRIOR TO REPAIR, STEAM SYSTEM WILL NEED TO BE SHUT DOWN TO WORK ON THIS ELEMENT, STEAM LINES WILL ONLY BE ABLE TO BE SHUT DOWN ONE AT A TIME AND ANCHORS WILL ONLY BE ABLE TO BE REPLACED ONE AT A TIME. CONTRACTOR SHALL COORDINATE WITH OWNER ONE WEEK IN ADVANCE FOR SYSTEM SHUT DOWN. REMOVE TEMPORARY BRACING ONCE NEW BASE PLATES ARE INSTALLED. ADDITIONALLY, ALL RUST ON COLUMNS SHALL BE REMOVED & SHALL BE HOT GALV. FINISHED.

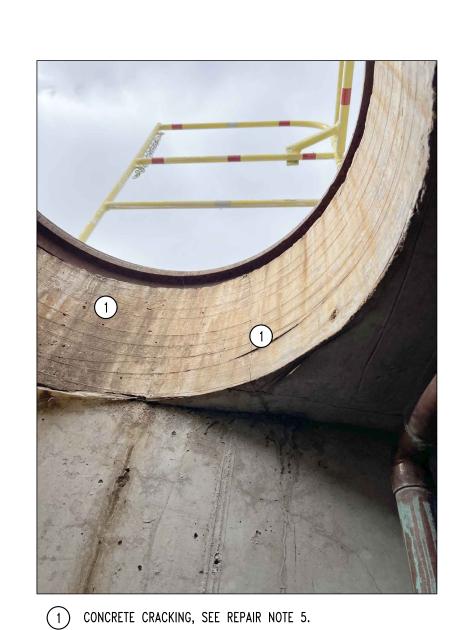
SMH #638 - CHAMPIONS DR.

1 CONCRETE CRACKING, SEE CRACK REPAIR DETAIL ON SHEET S200.

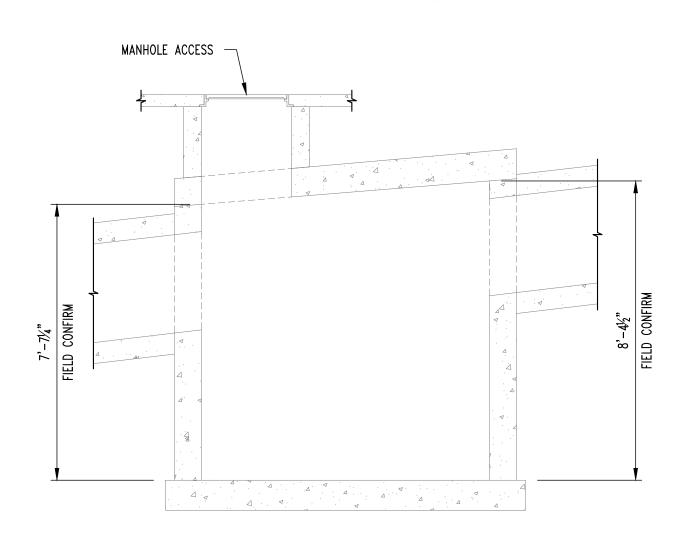
1) DEAD SPOT UNDER CHASE, SEE REPAIR NOTE 1.

- 1. AREA UNDER CHASE 6'-0"x2'-0"x0'-3" TALL. (REPAIR #3 EXPECTED)
- 2. REPLACE SIDEWALK ABOVE STEAM MAN HOLE, 15'-0"x10'-0" w/ 5" SLAB w/ 6x6 W2.9xW2.9WWF.
- w/ 6x6 WZ.9xWZ.9WWF.
- 3. AROUND THE CHASE THERE ARE CRACKS NEEDING INJECTED, APPROX. 10 LINEAR FEET. (REPAIR #4)
- 4. SPALLED AREA 12"x24" ABOVE CHASE. (REPAIR #2)
- 5. VERTICAL CRACK PRESENT IN RISER, APPROX. 2 LINEAR FEET. (REPAIR #4)

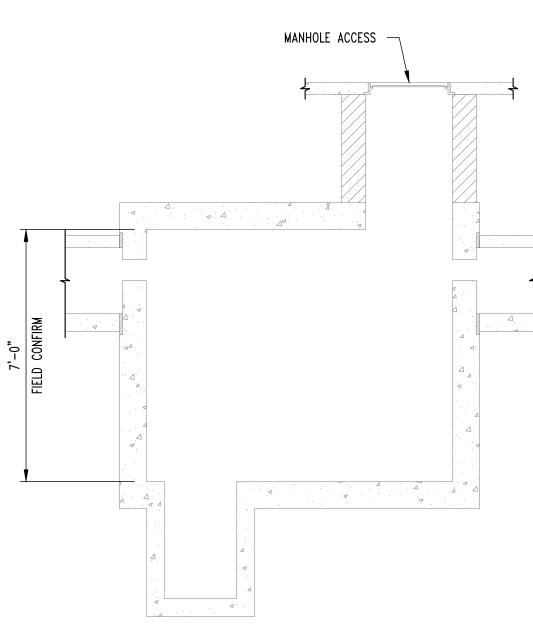
1) SPALLED CONCRETE, SEE REPAIR NOTE 4.

- 2 LADDER DOES NOT MEET CODE, REMOVE AND REPLACE.

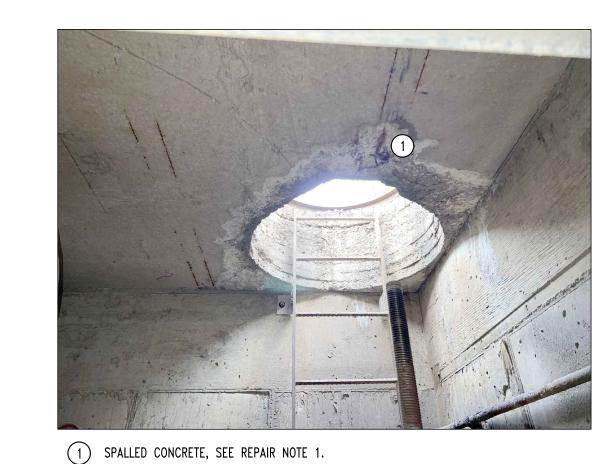
1 DEEP SPALL, SEE REPAIR NOTE 2. SMH #414 - SOUTH COLLEGE AVE.
